# DOI FY 07 Aviation Mishaps

# DOI FY 07/08 Aviation Mishaps

This information is provided  
for accident prevention purposes only

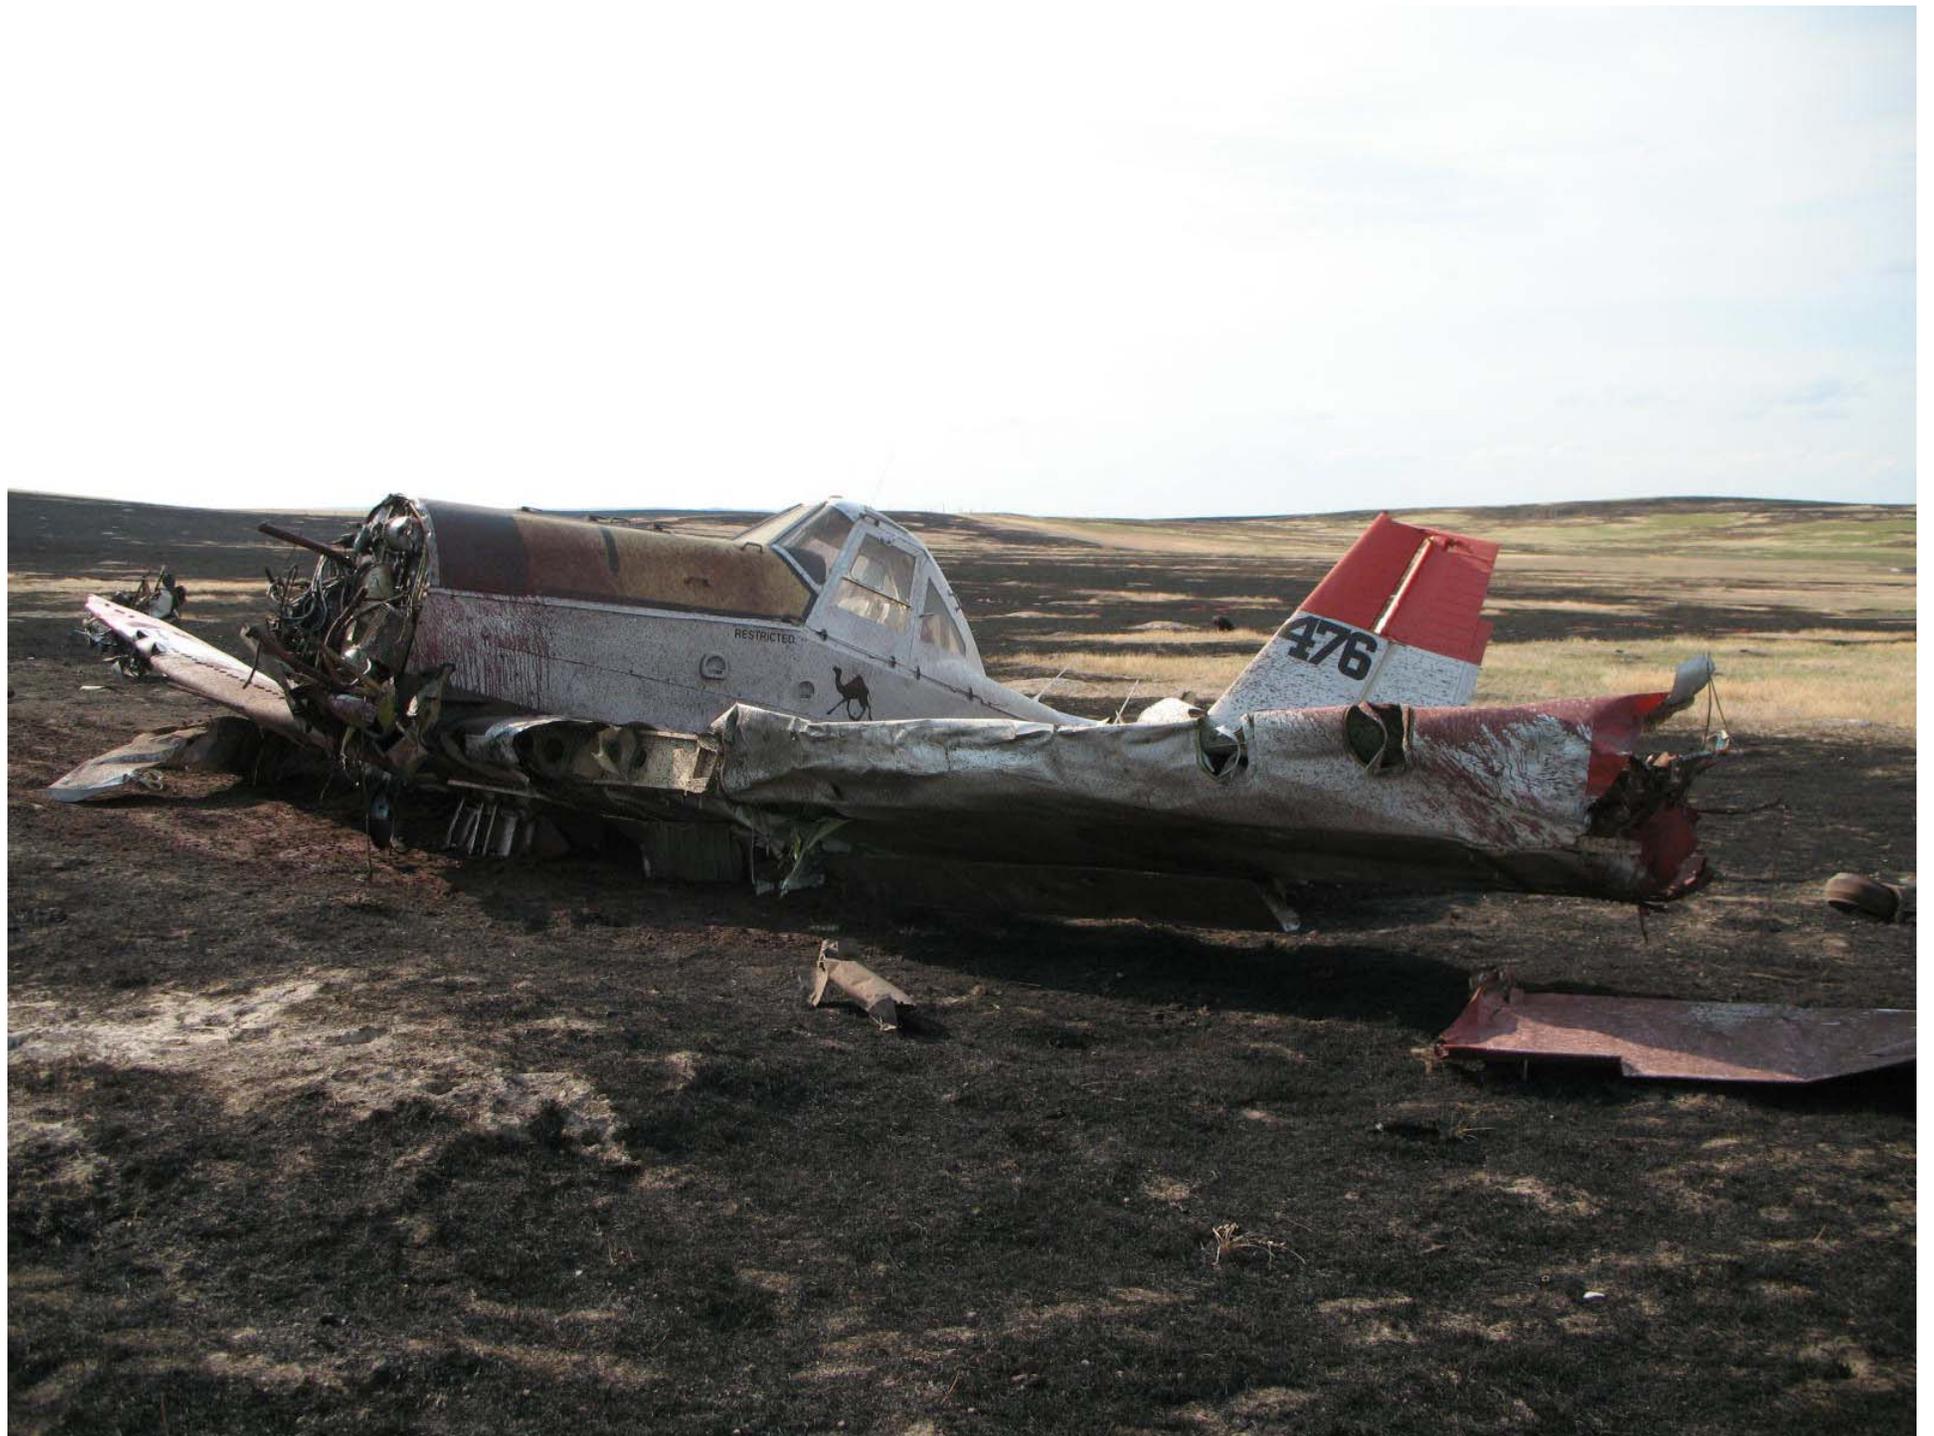
**Eyewitness described aircraft in 60° left bank immediately before impact**

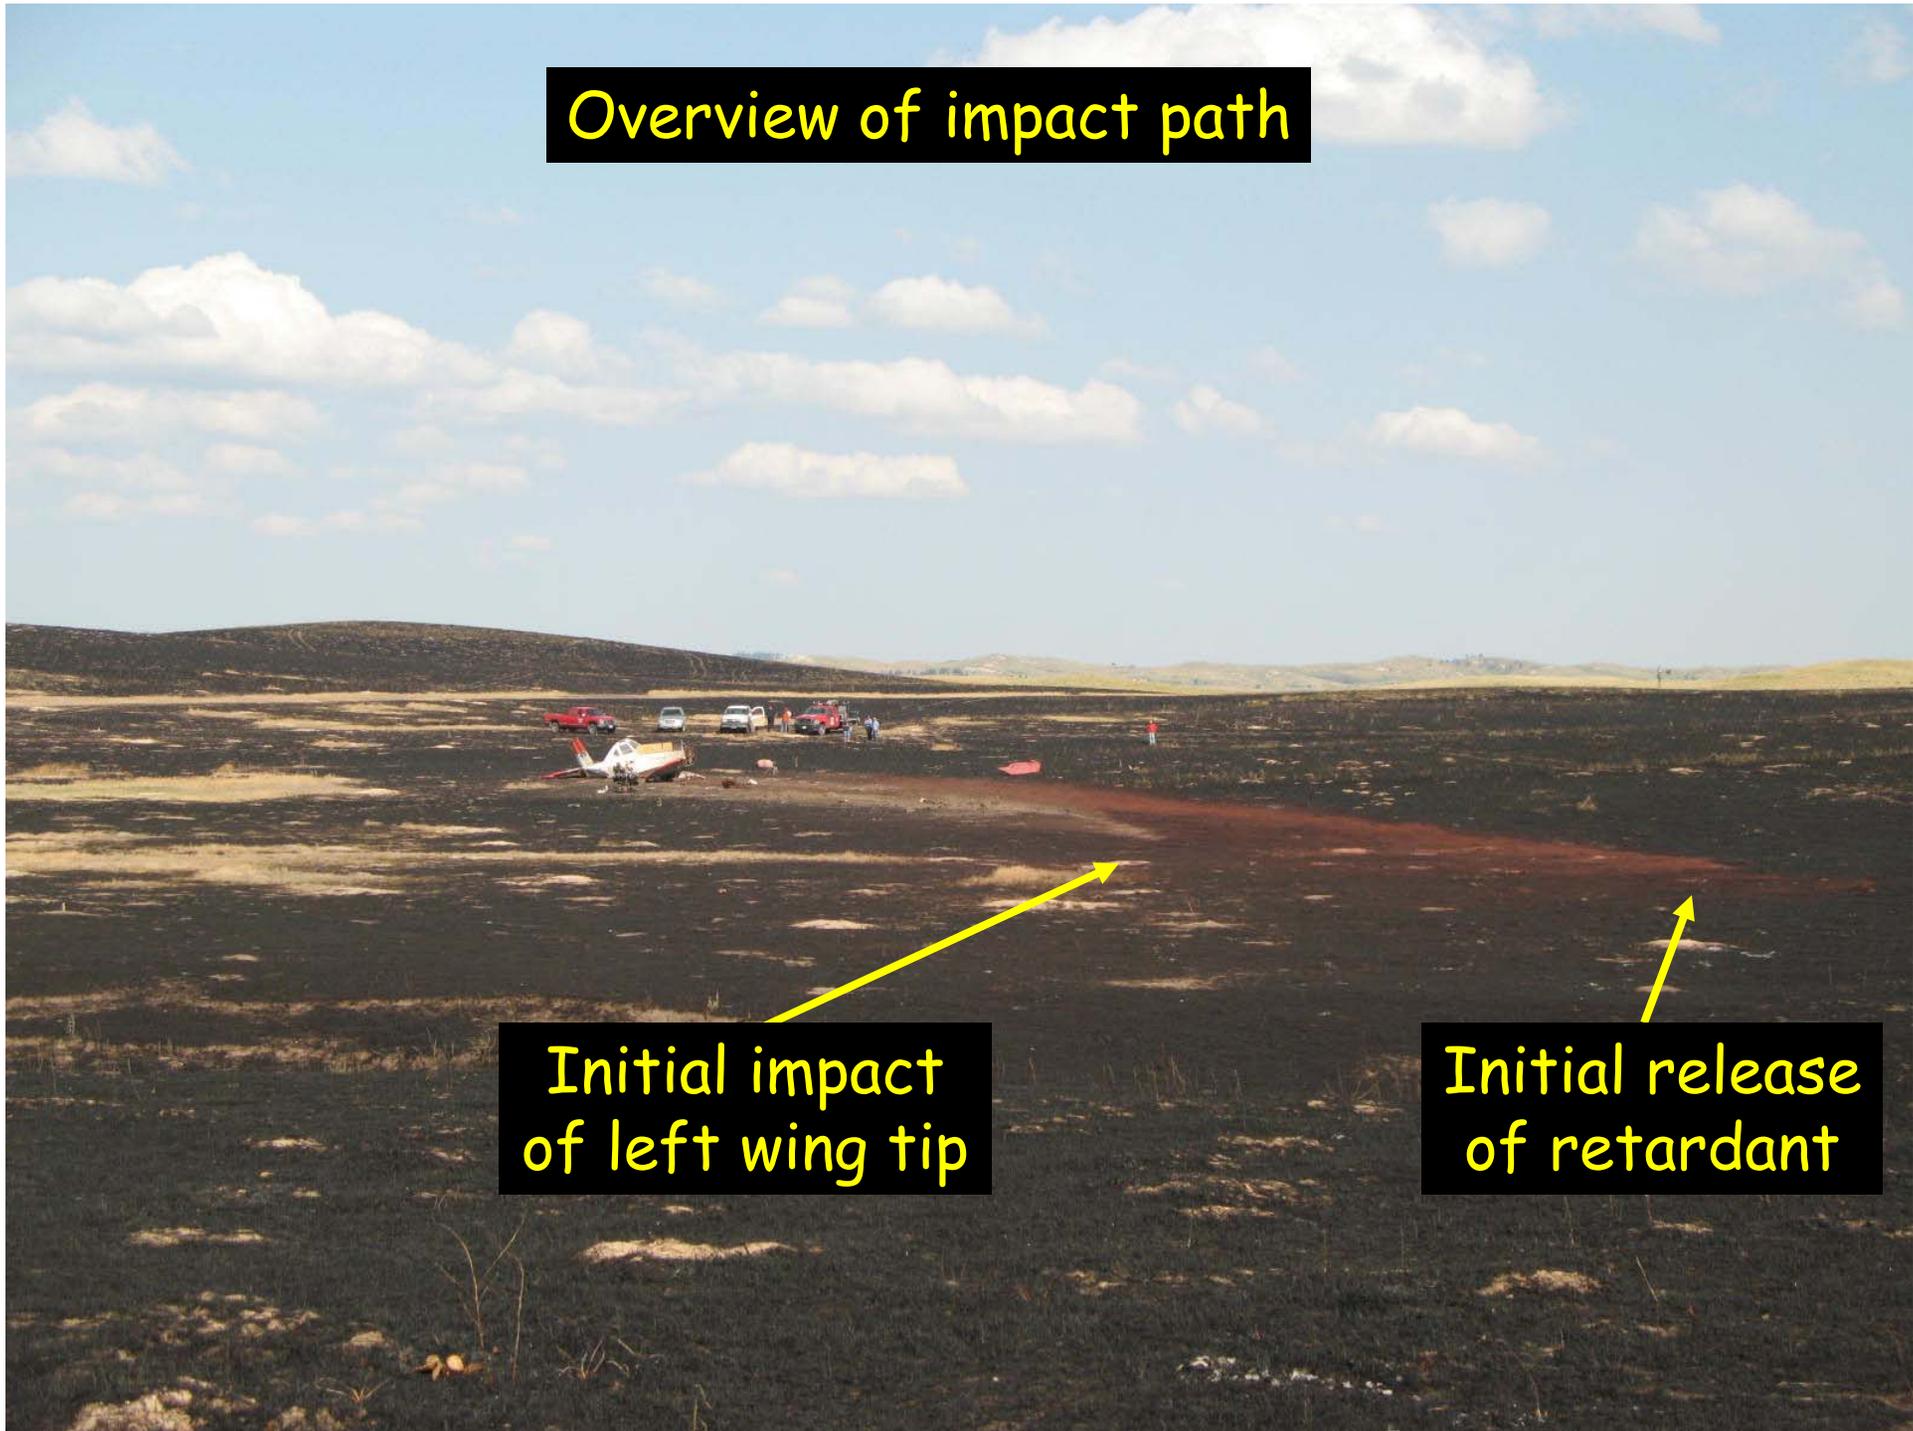
# Overview of impact path

Initial impact  
of left wing tip

Initial release  
of retardant

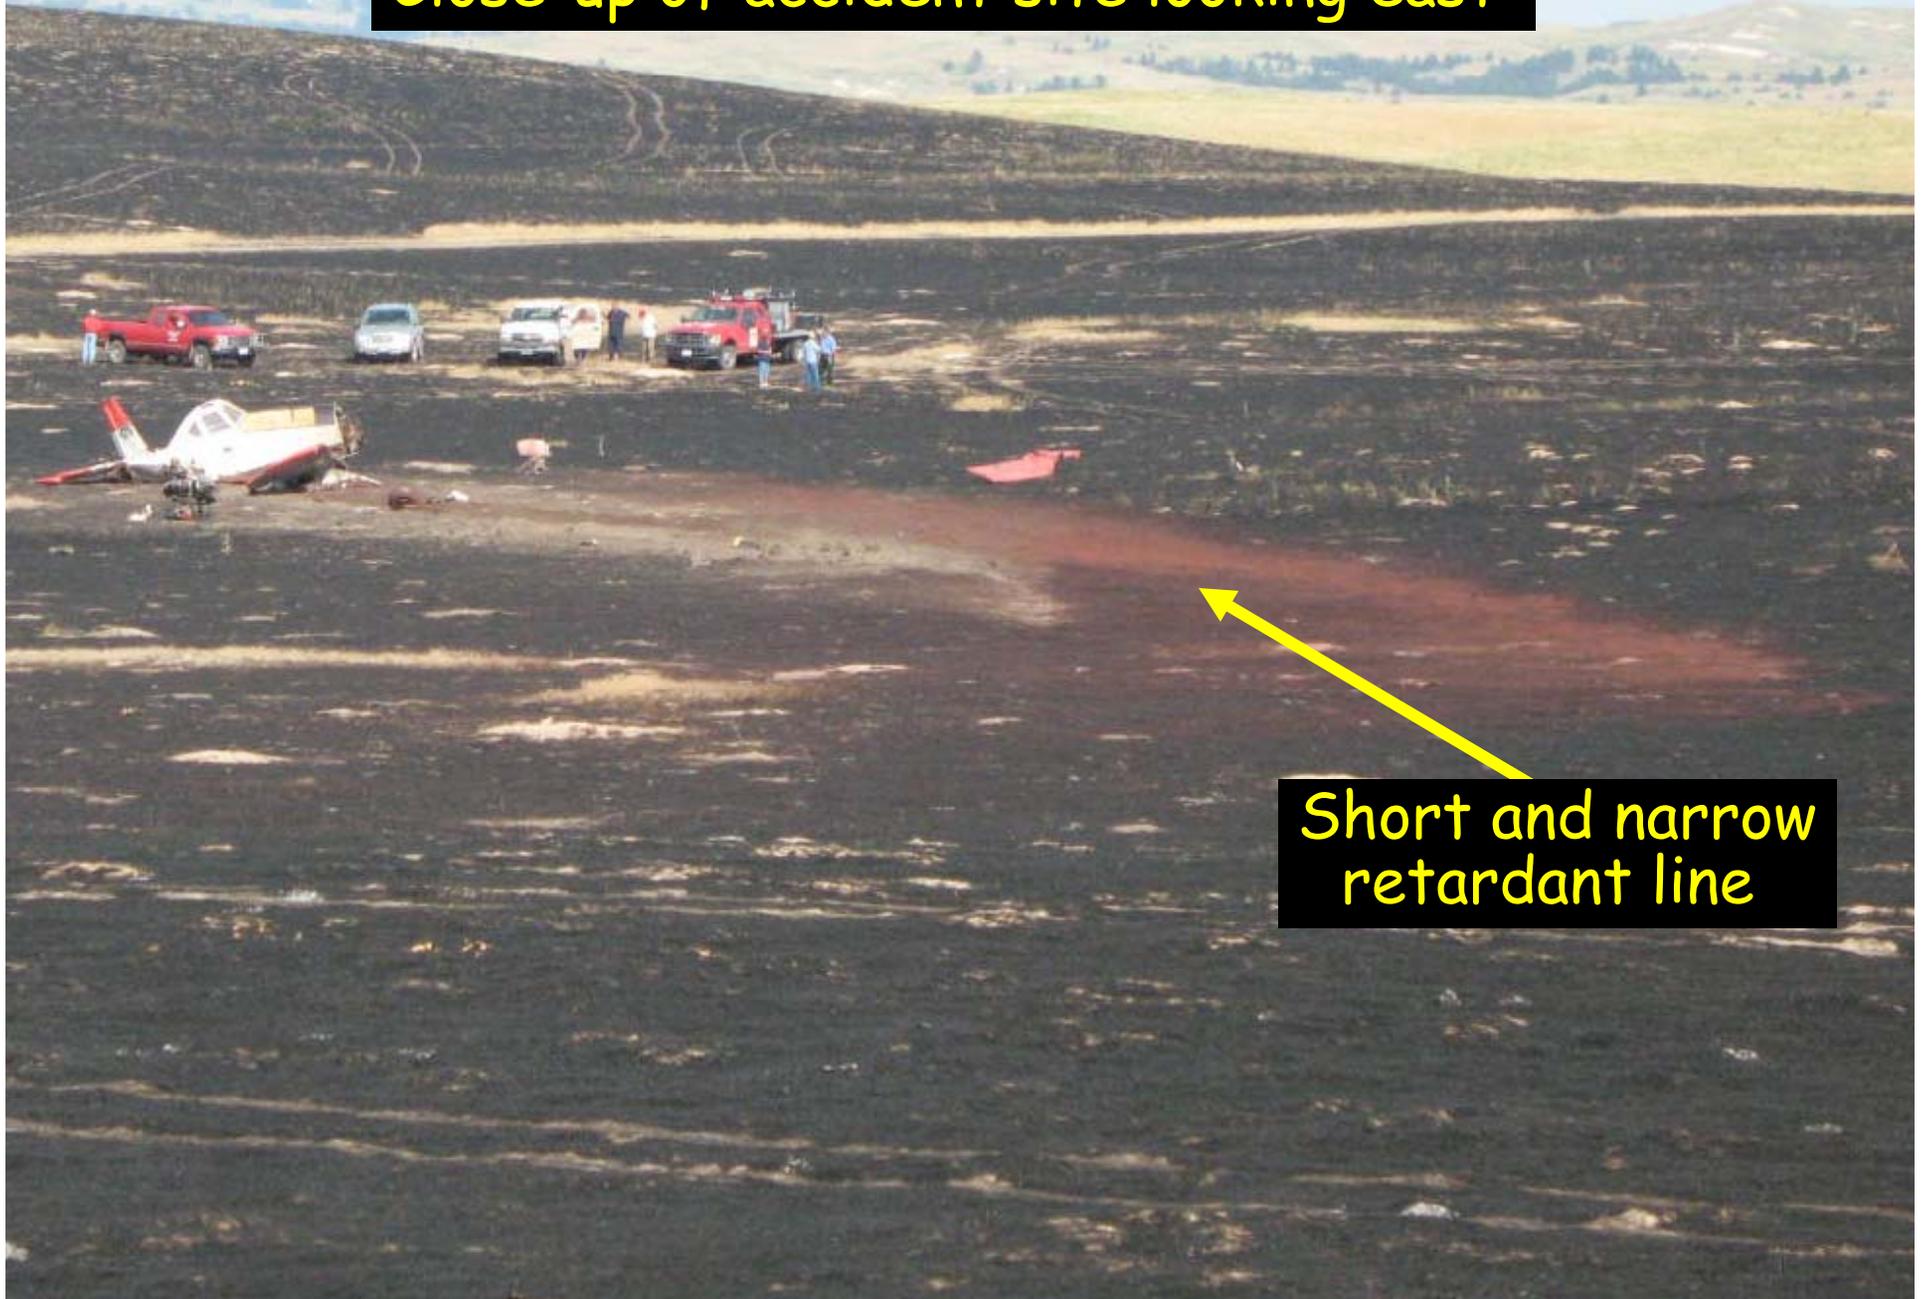
Close-up of accident site looking east

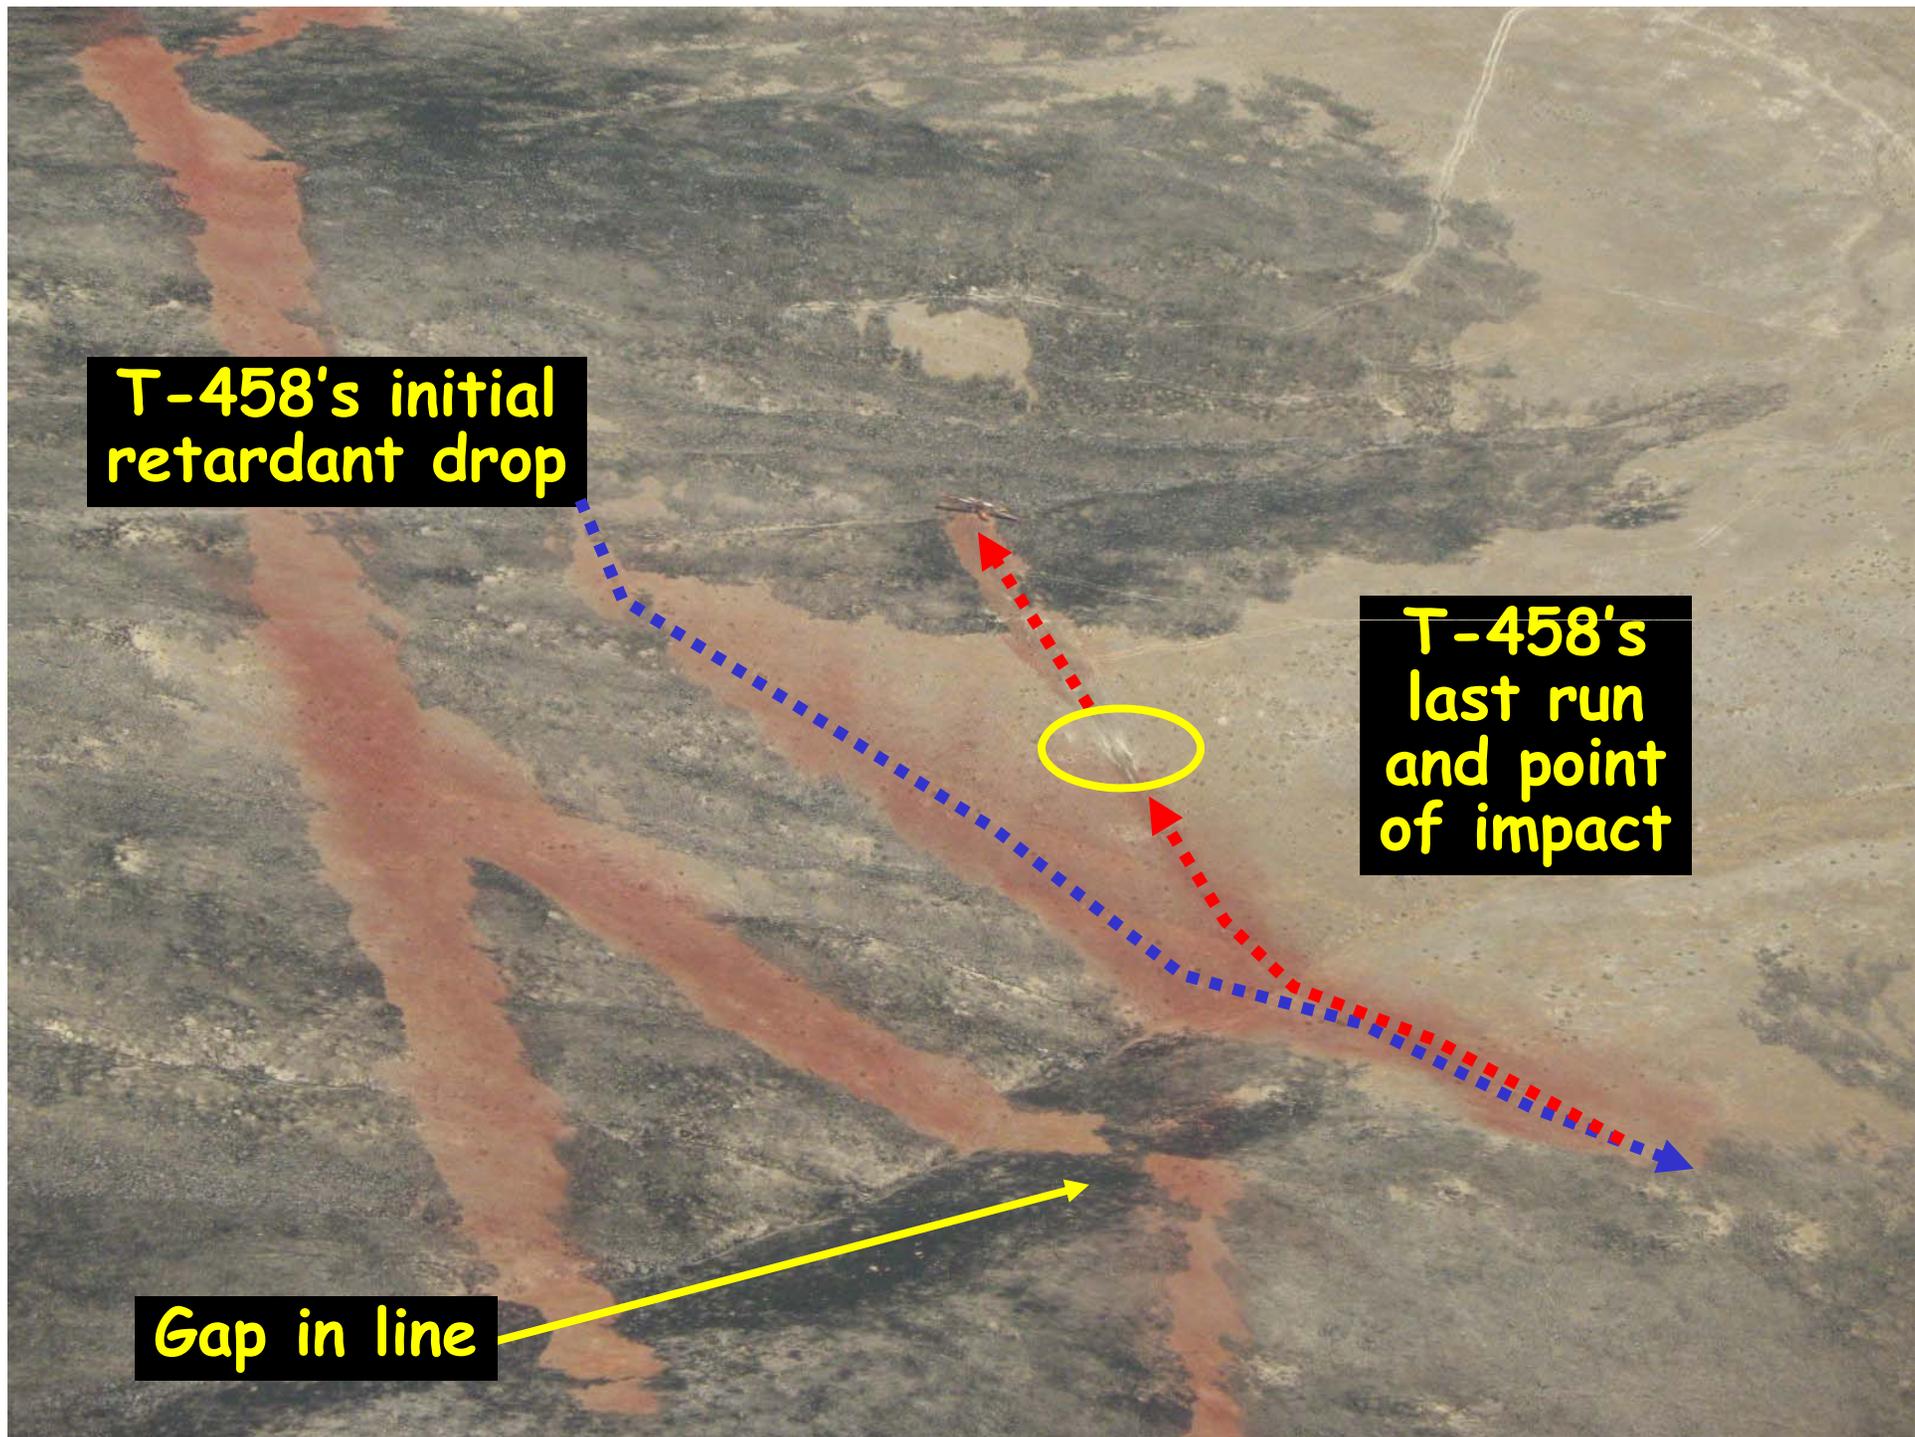
T-458's initial  
retardant drop

T-458's  
last run  
and point  
of impact

Gap in line

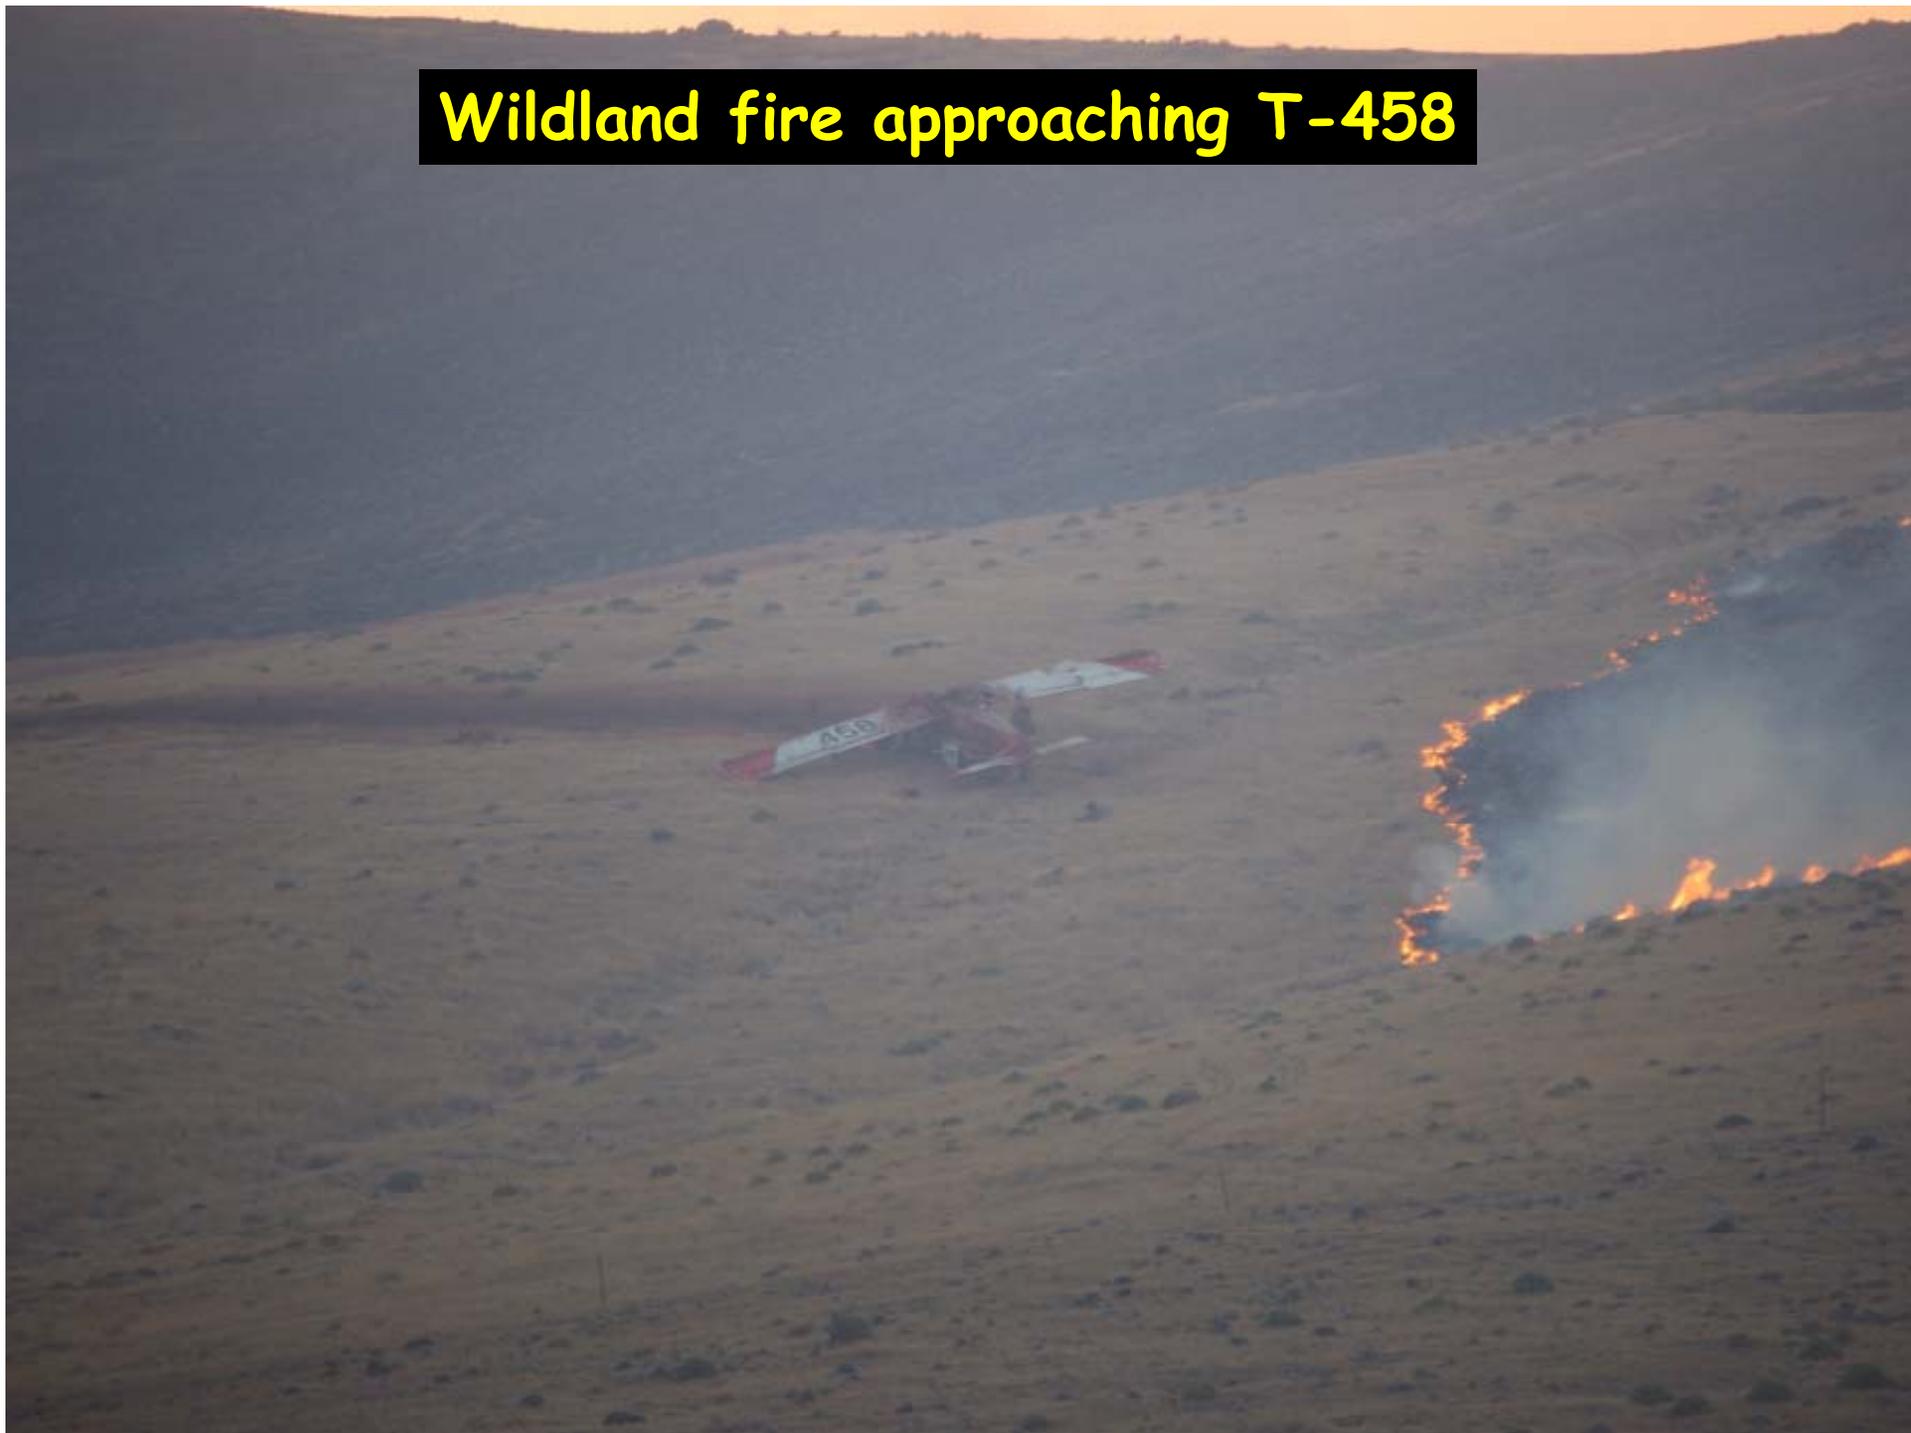
**Wildland fire approaching T-458**

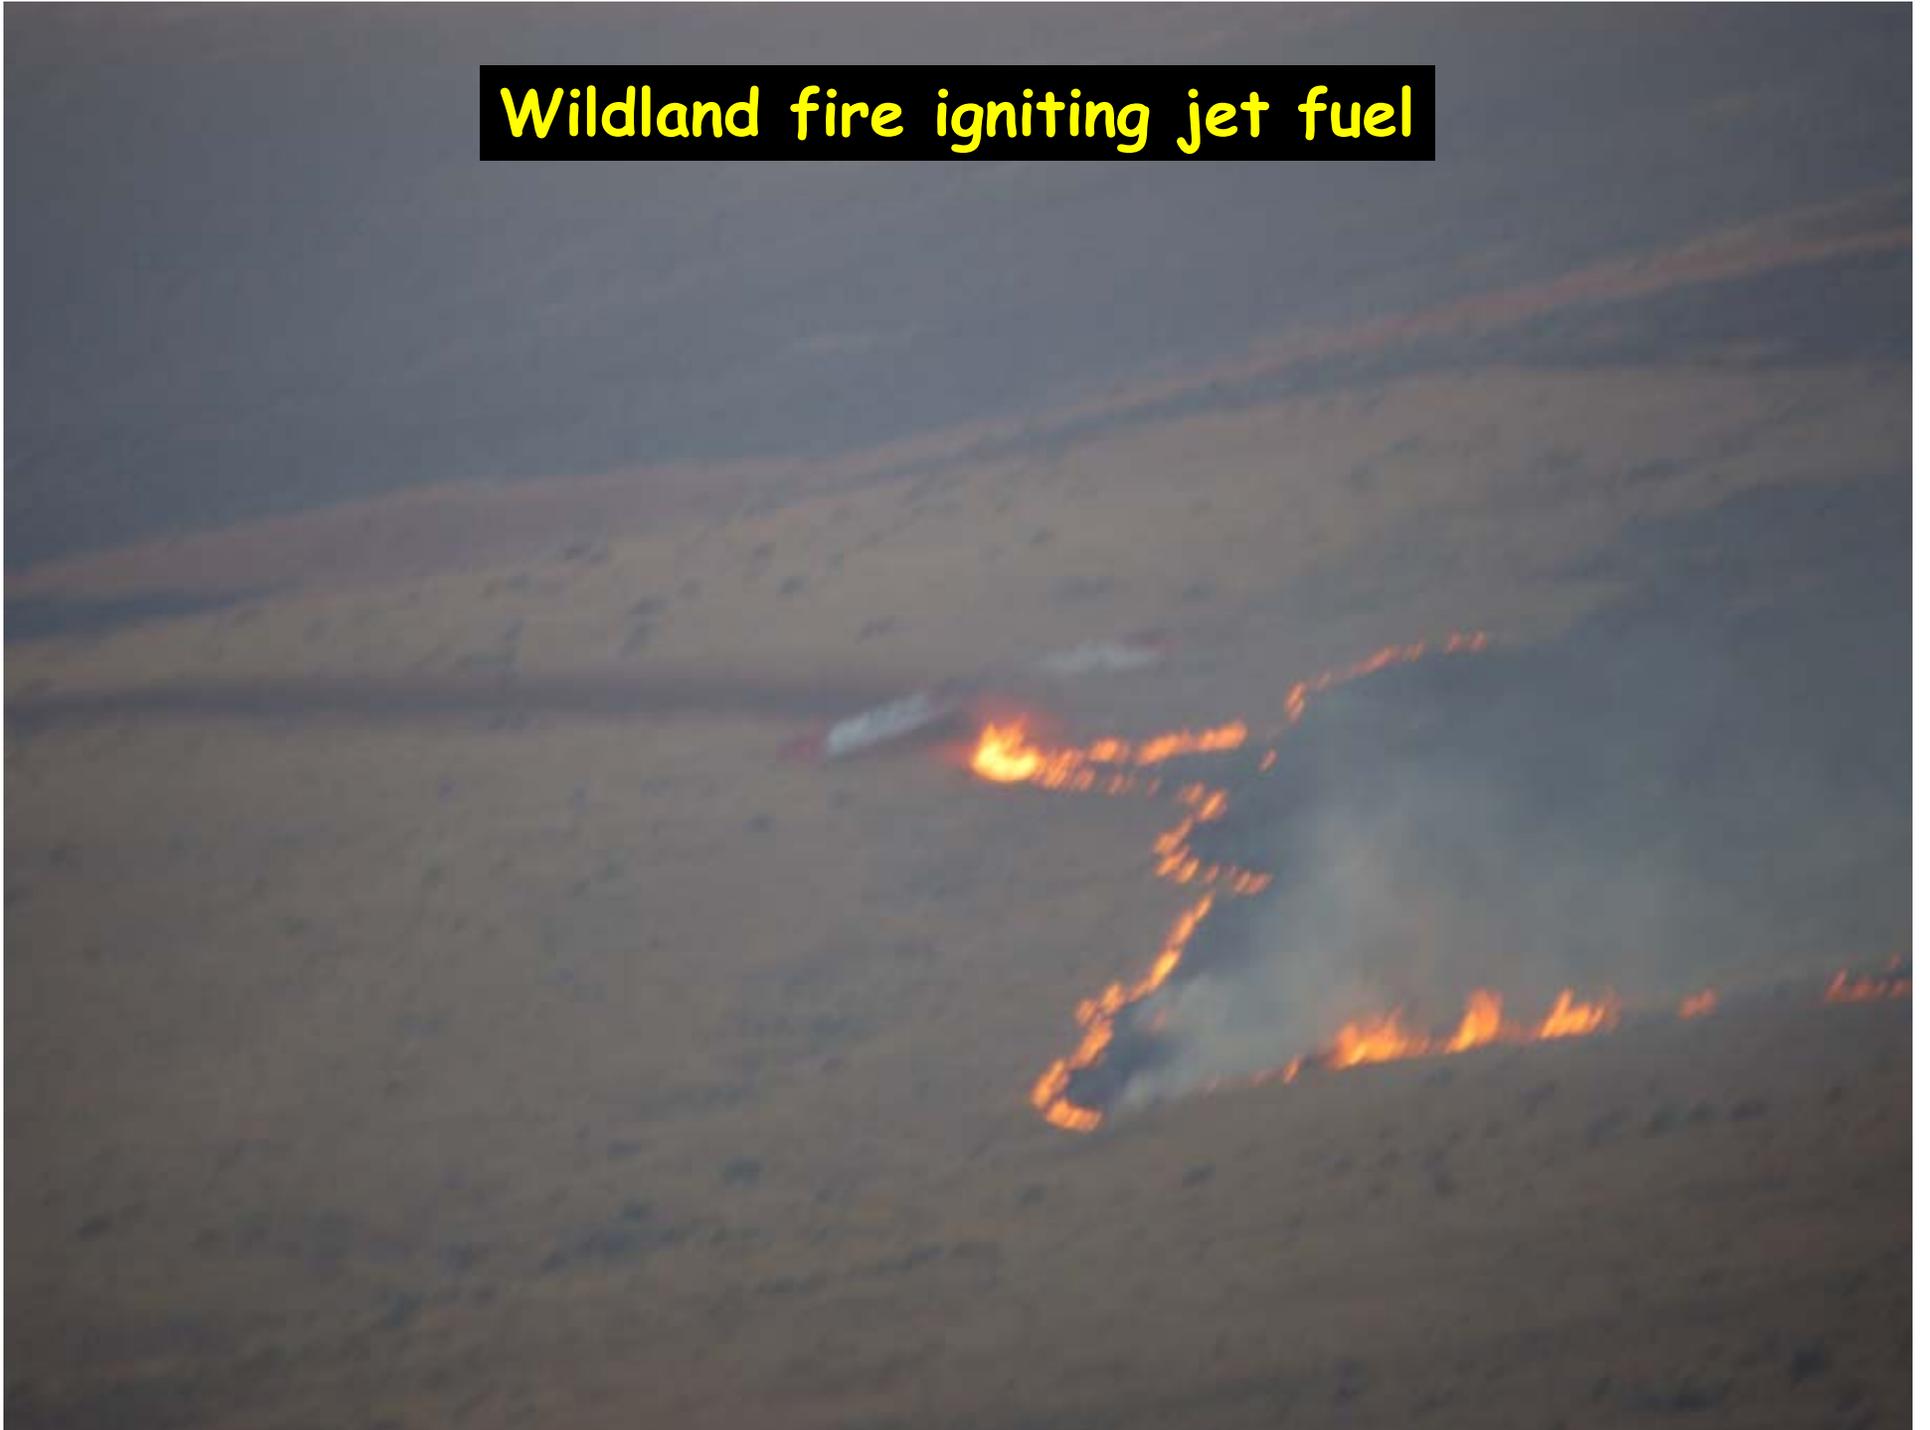
## Wildland fire igniting jet fuel

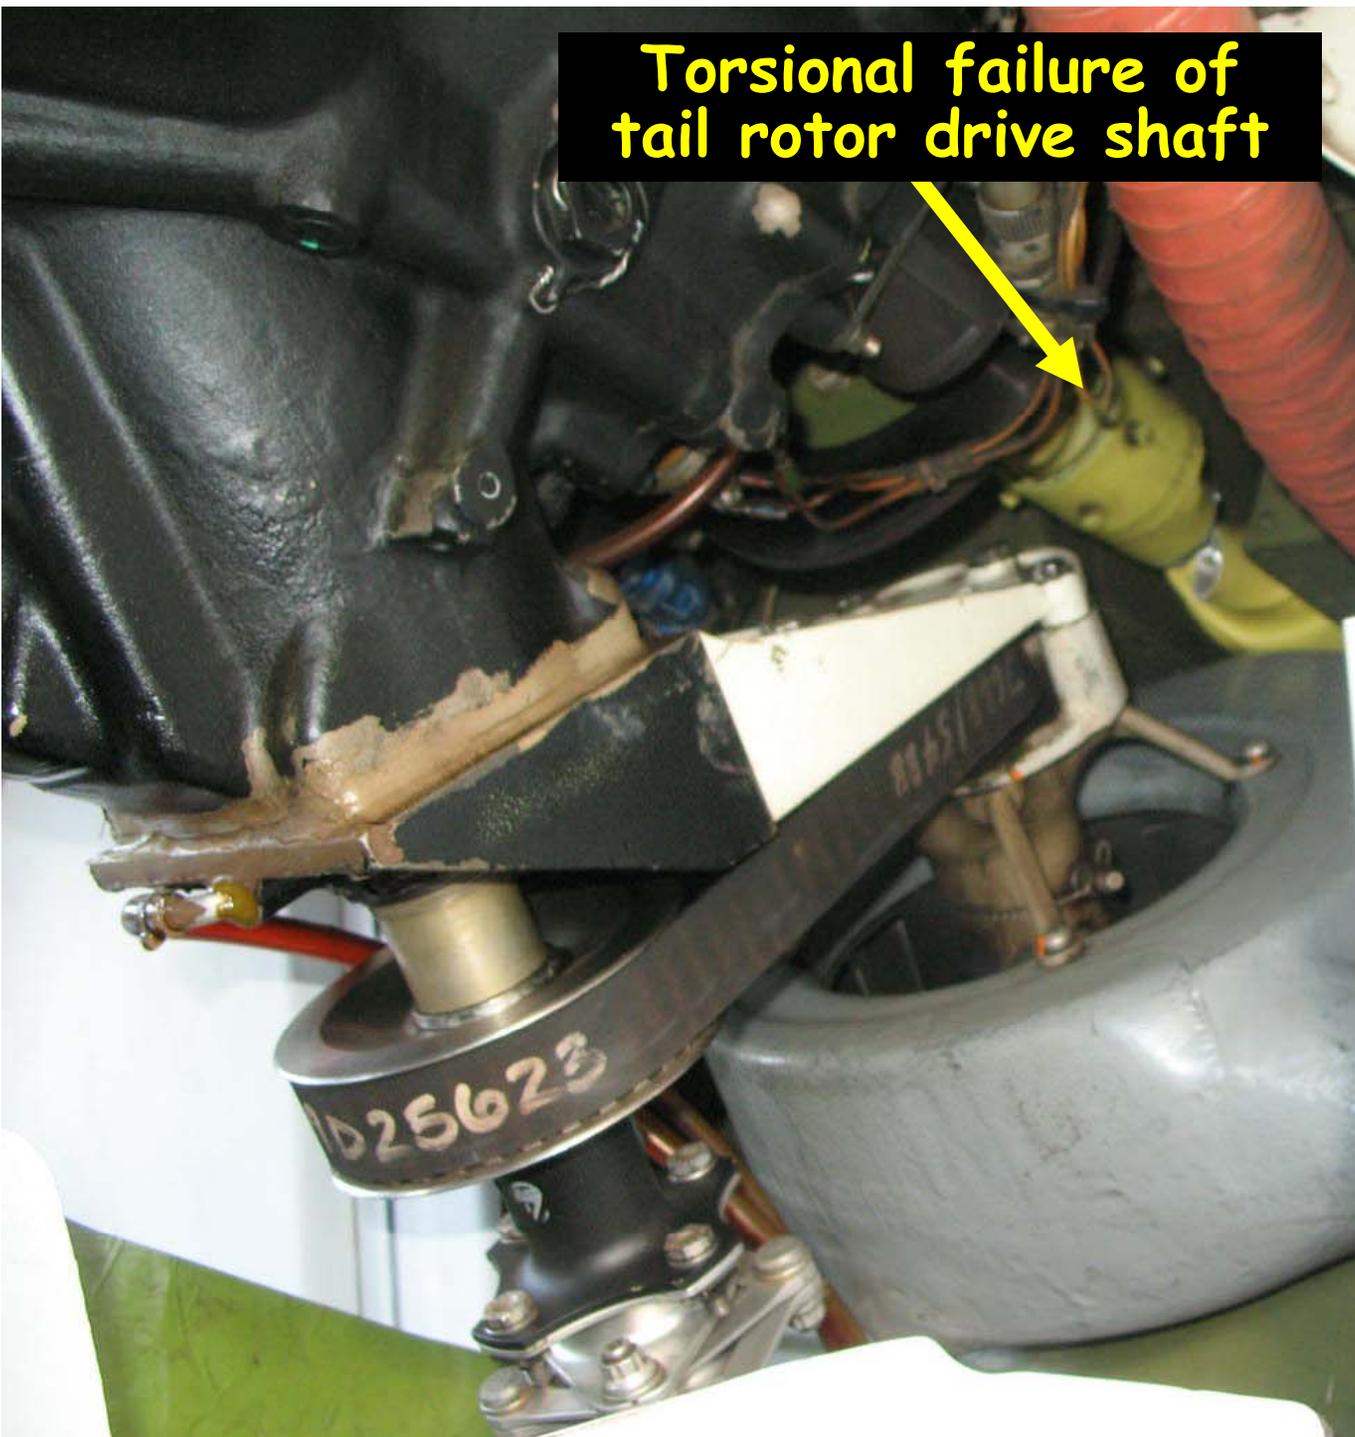
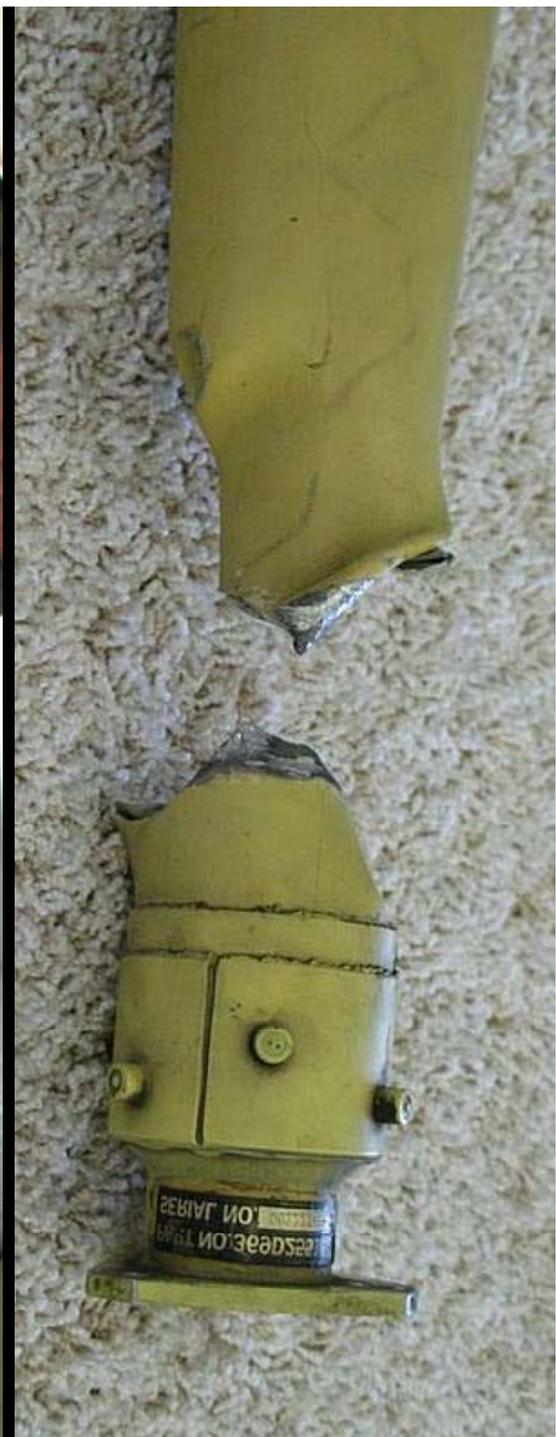
**The National Transportation Safety Board determines the probable cause(s) of this accident as follows:** The pilot's failure to maintain clearance from the surface of a pond that he was using as a water bucket refill site, which resulted in a tail rotor strike

**Torsional failure of  
tail rotor drive shaft**

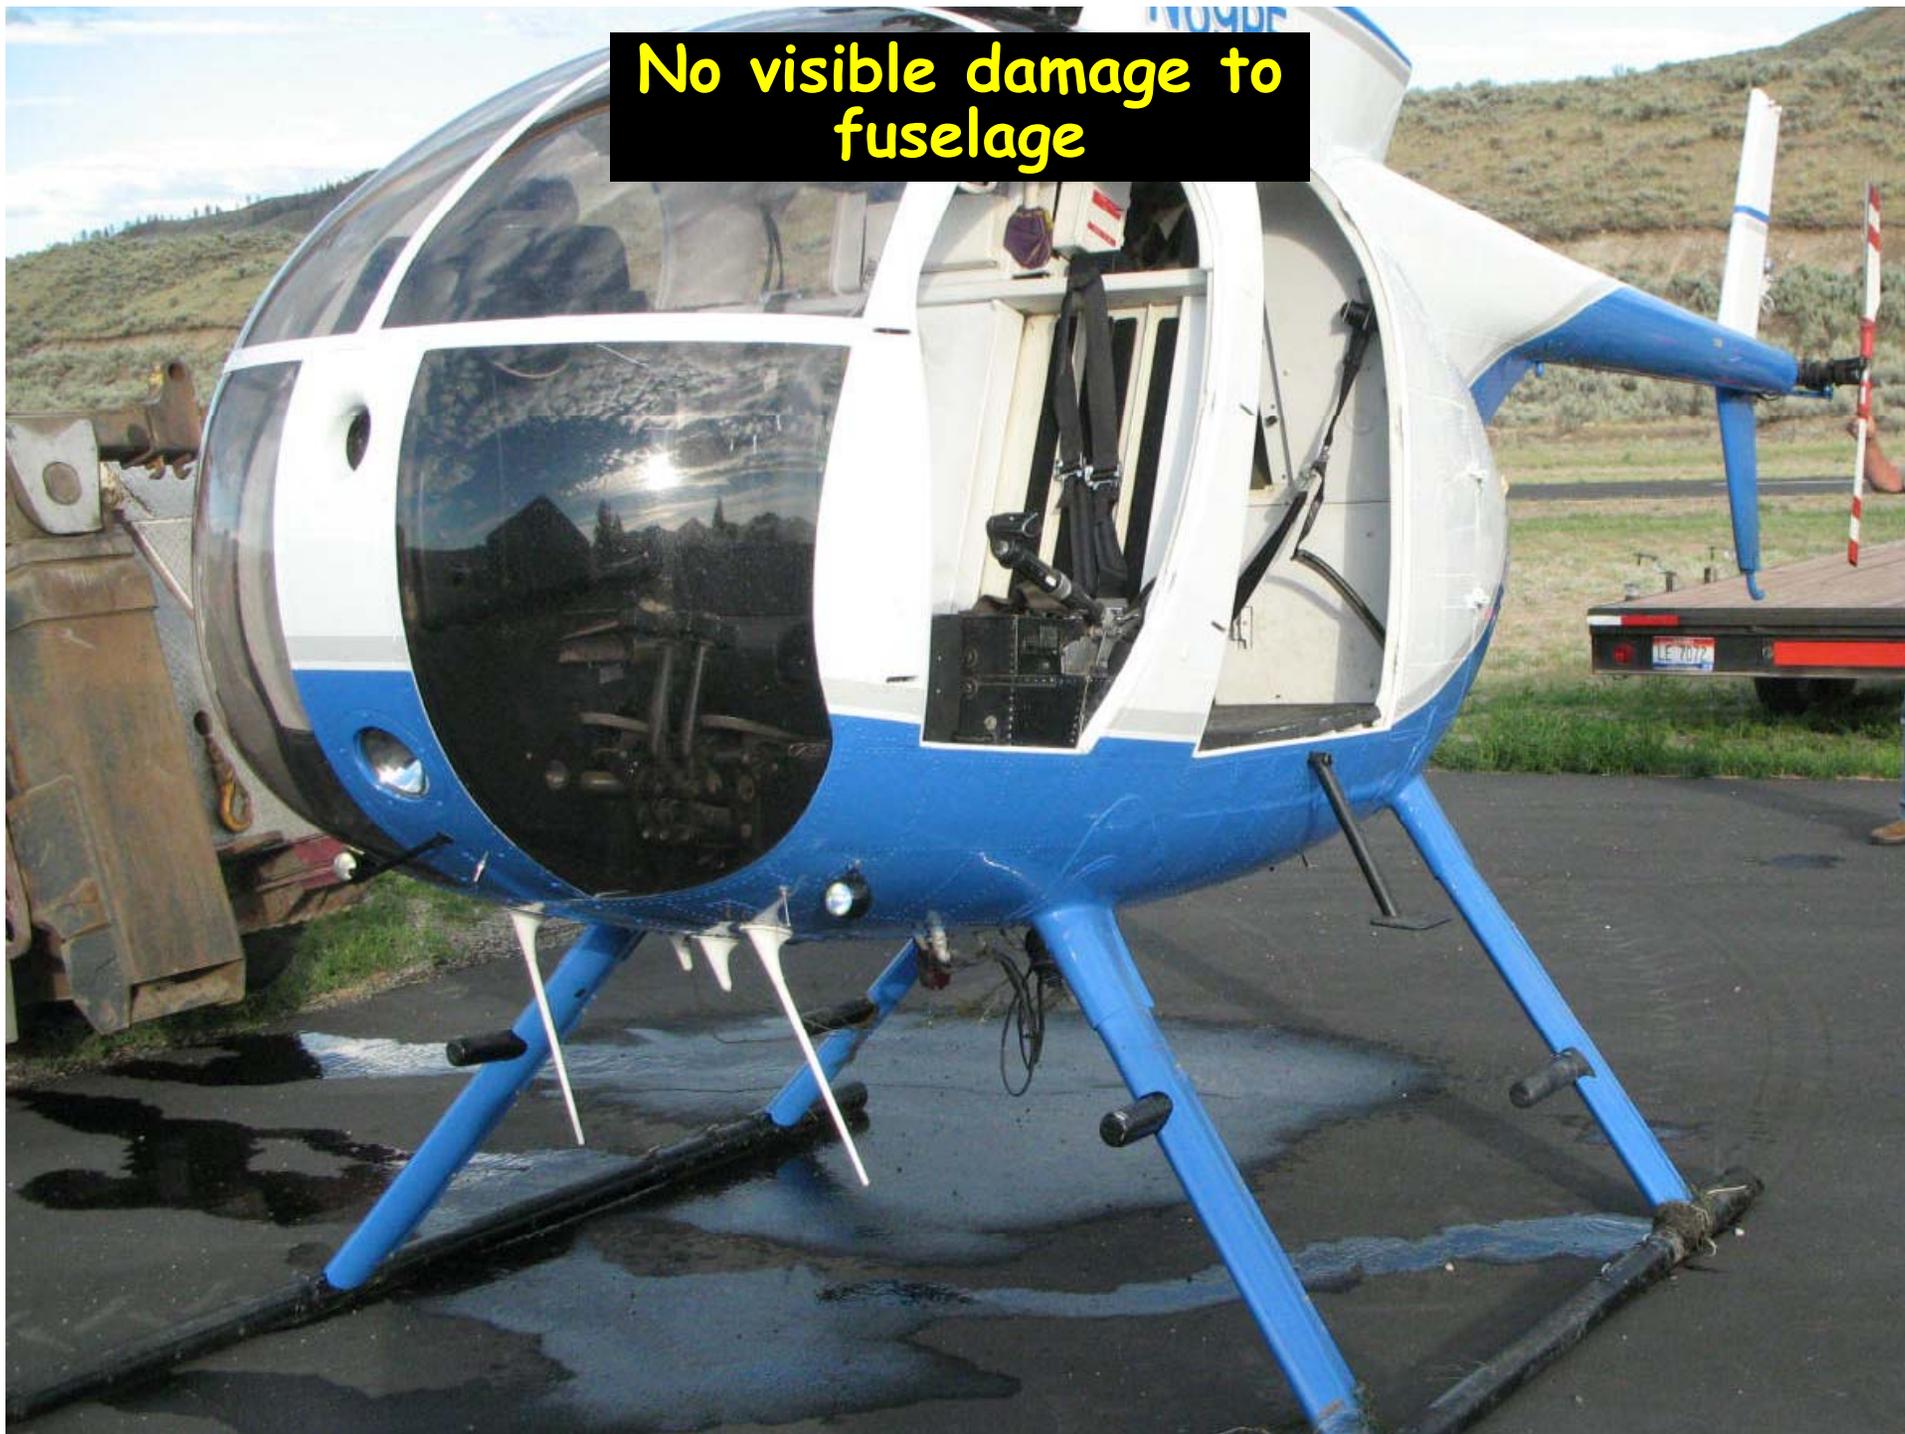
**No visible damage to fuselage**
