# DOI FY 07 Aviation Mishaps

# DOI FY 07/08 Aviation Mishaps

This information is provided  
for accident prevention purposes only

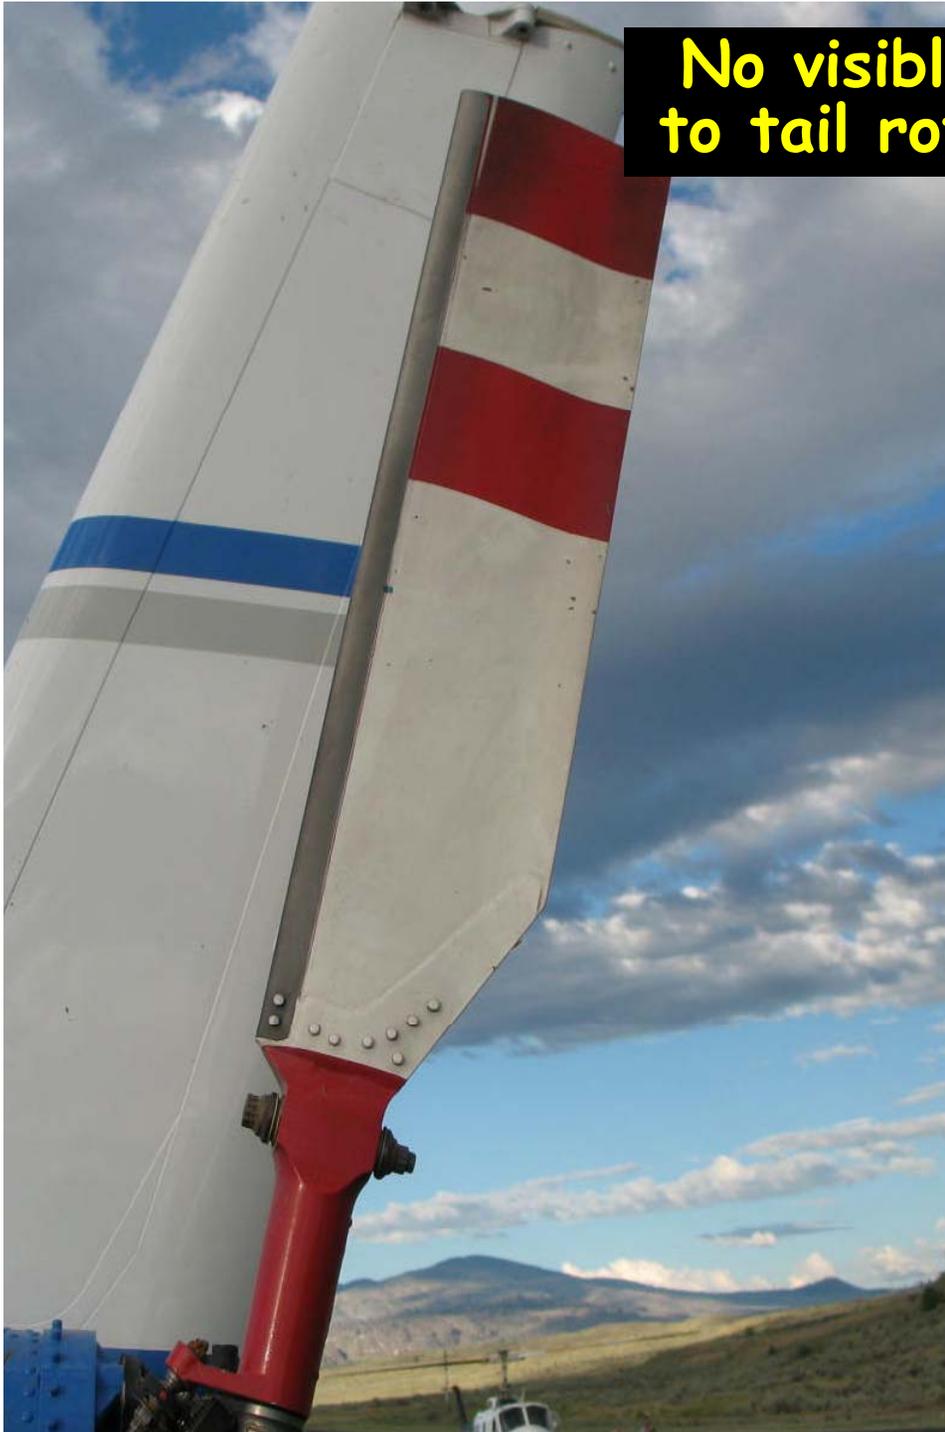
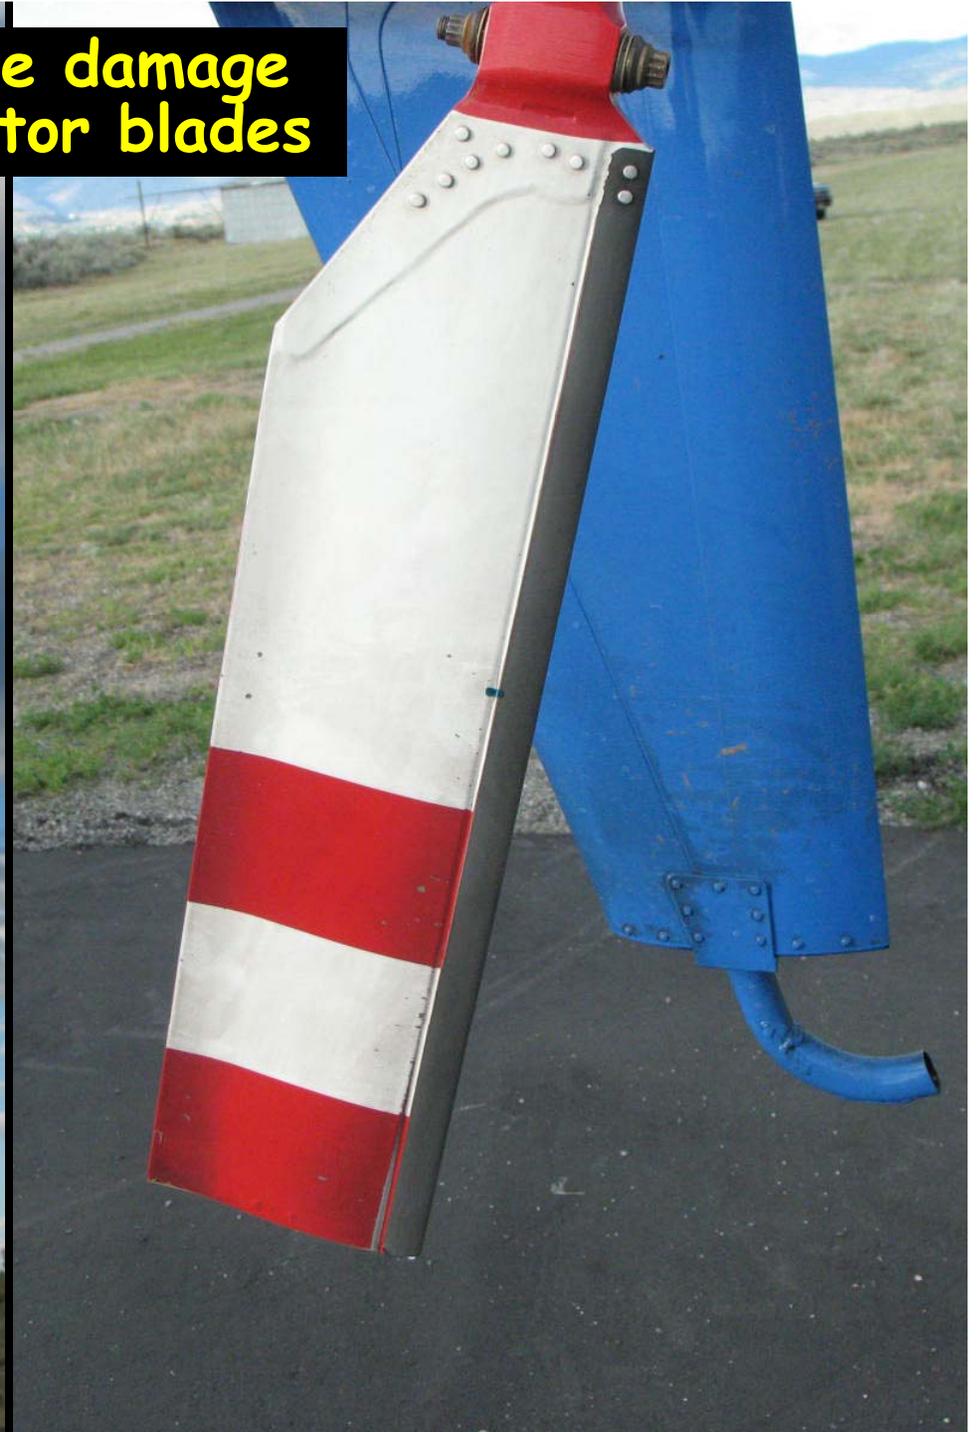
**No visible damage  
to tail rotor blades**

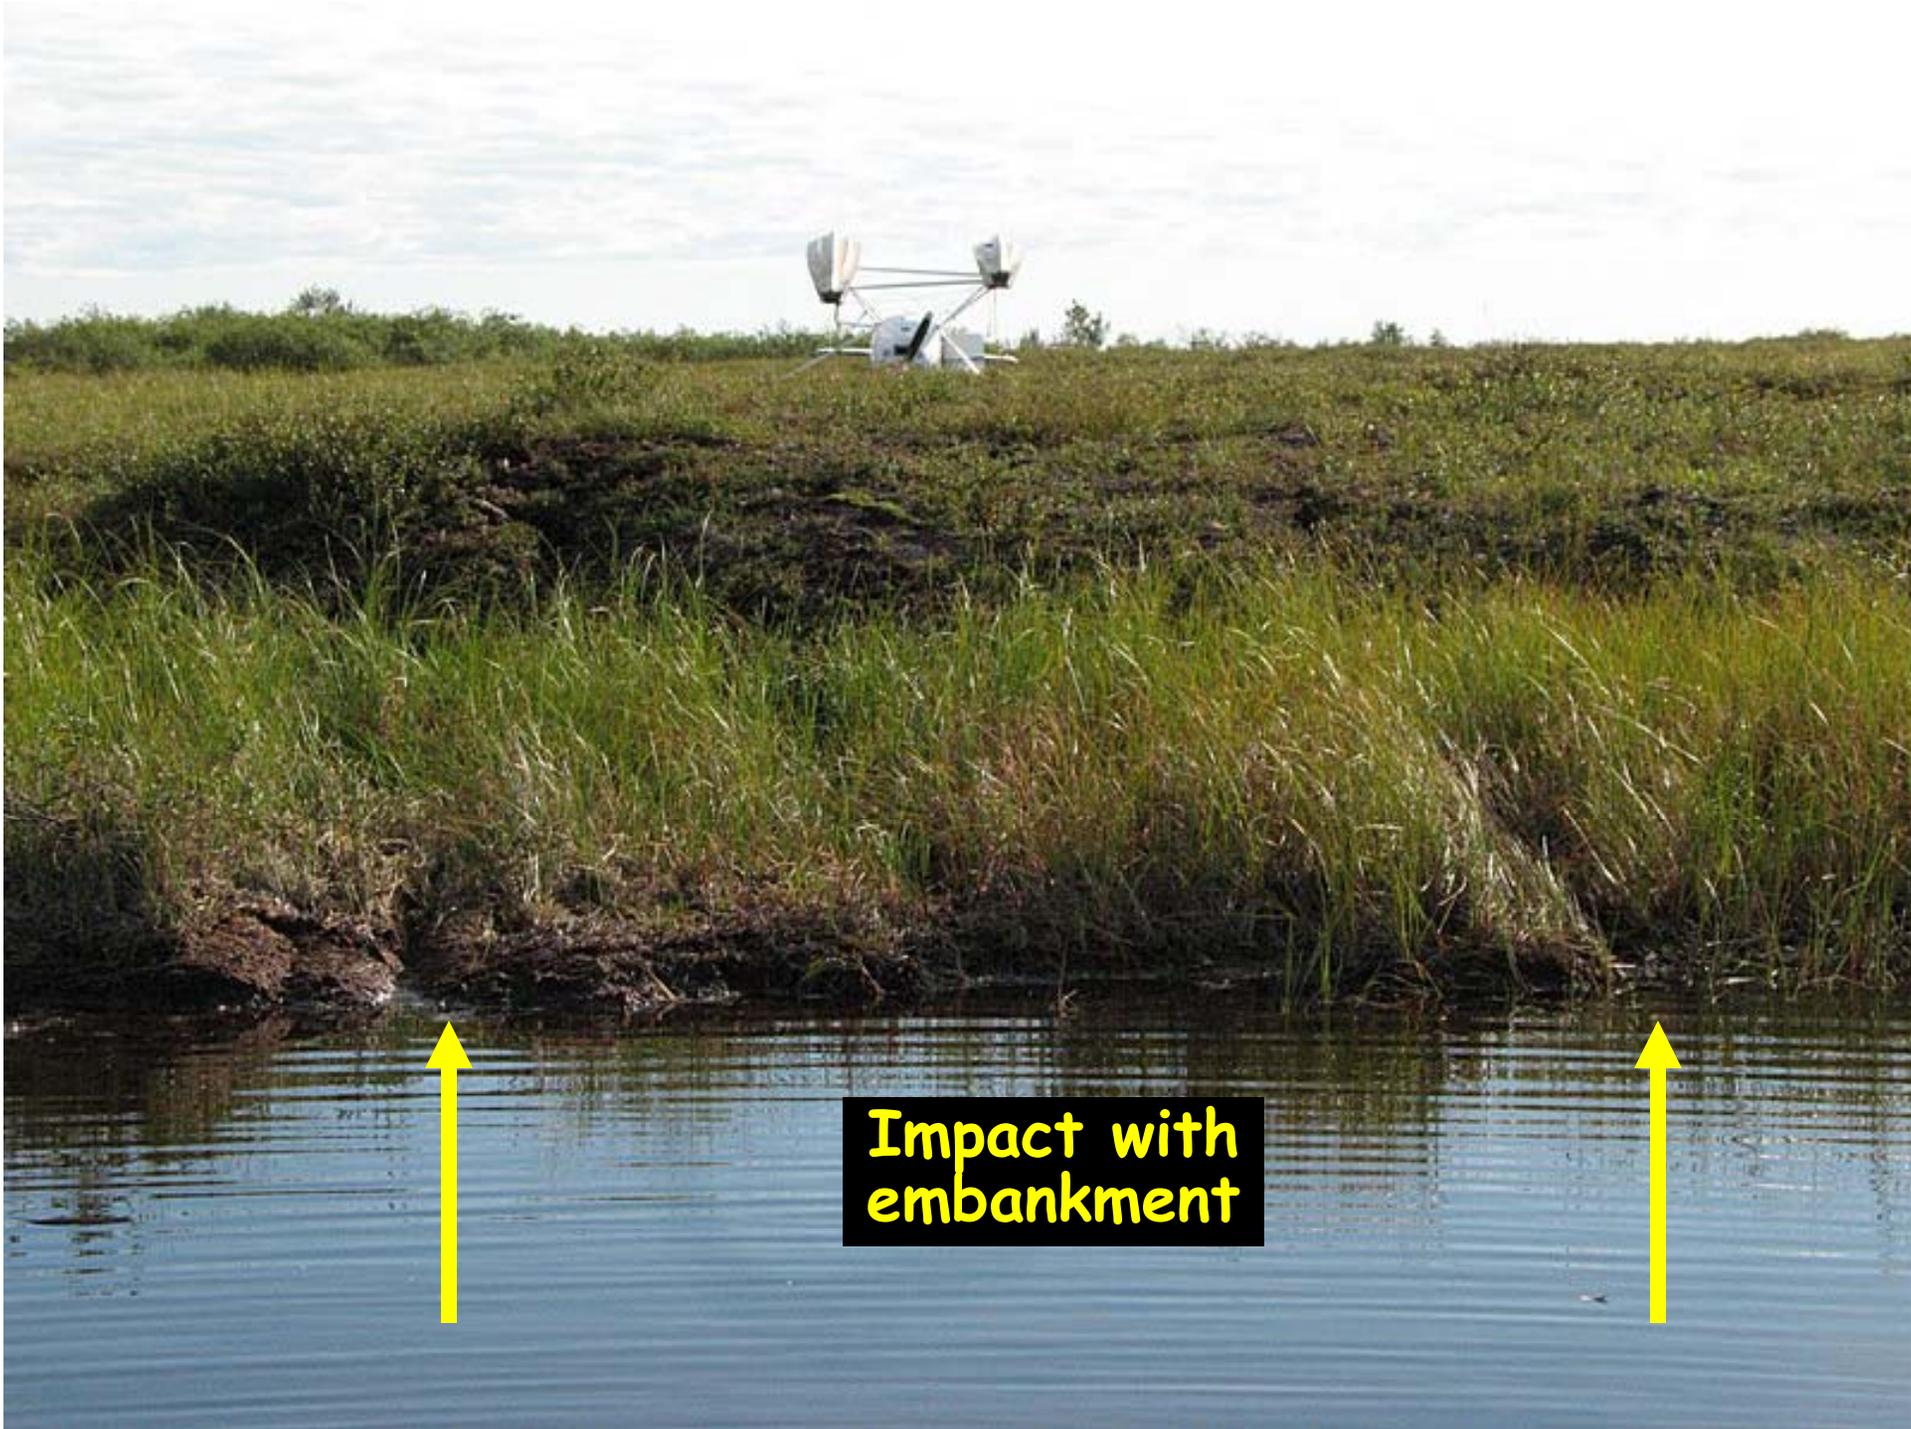
**Impact with  
embankment**

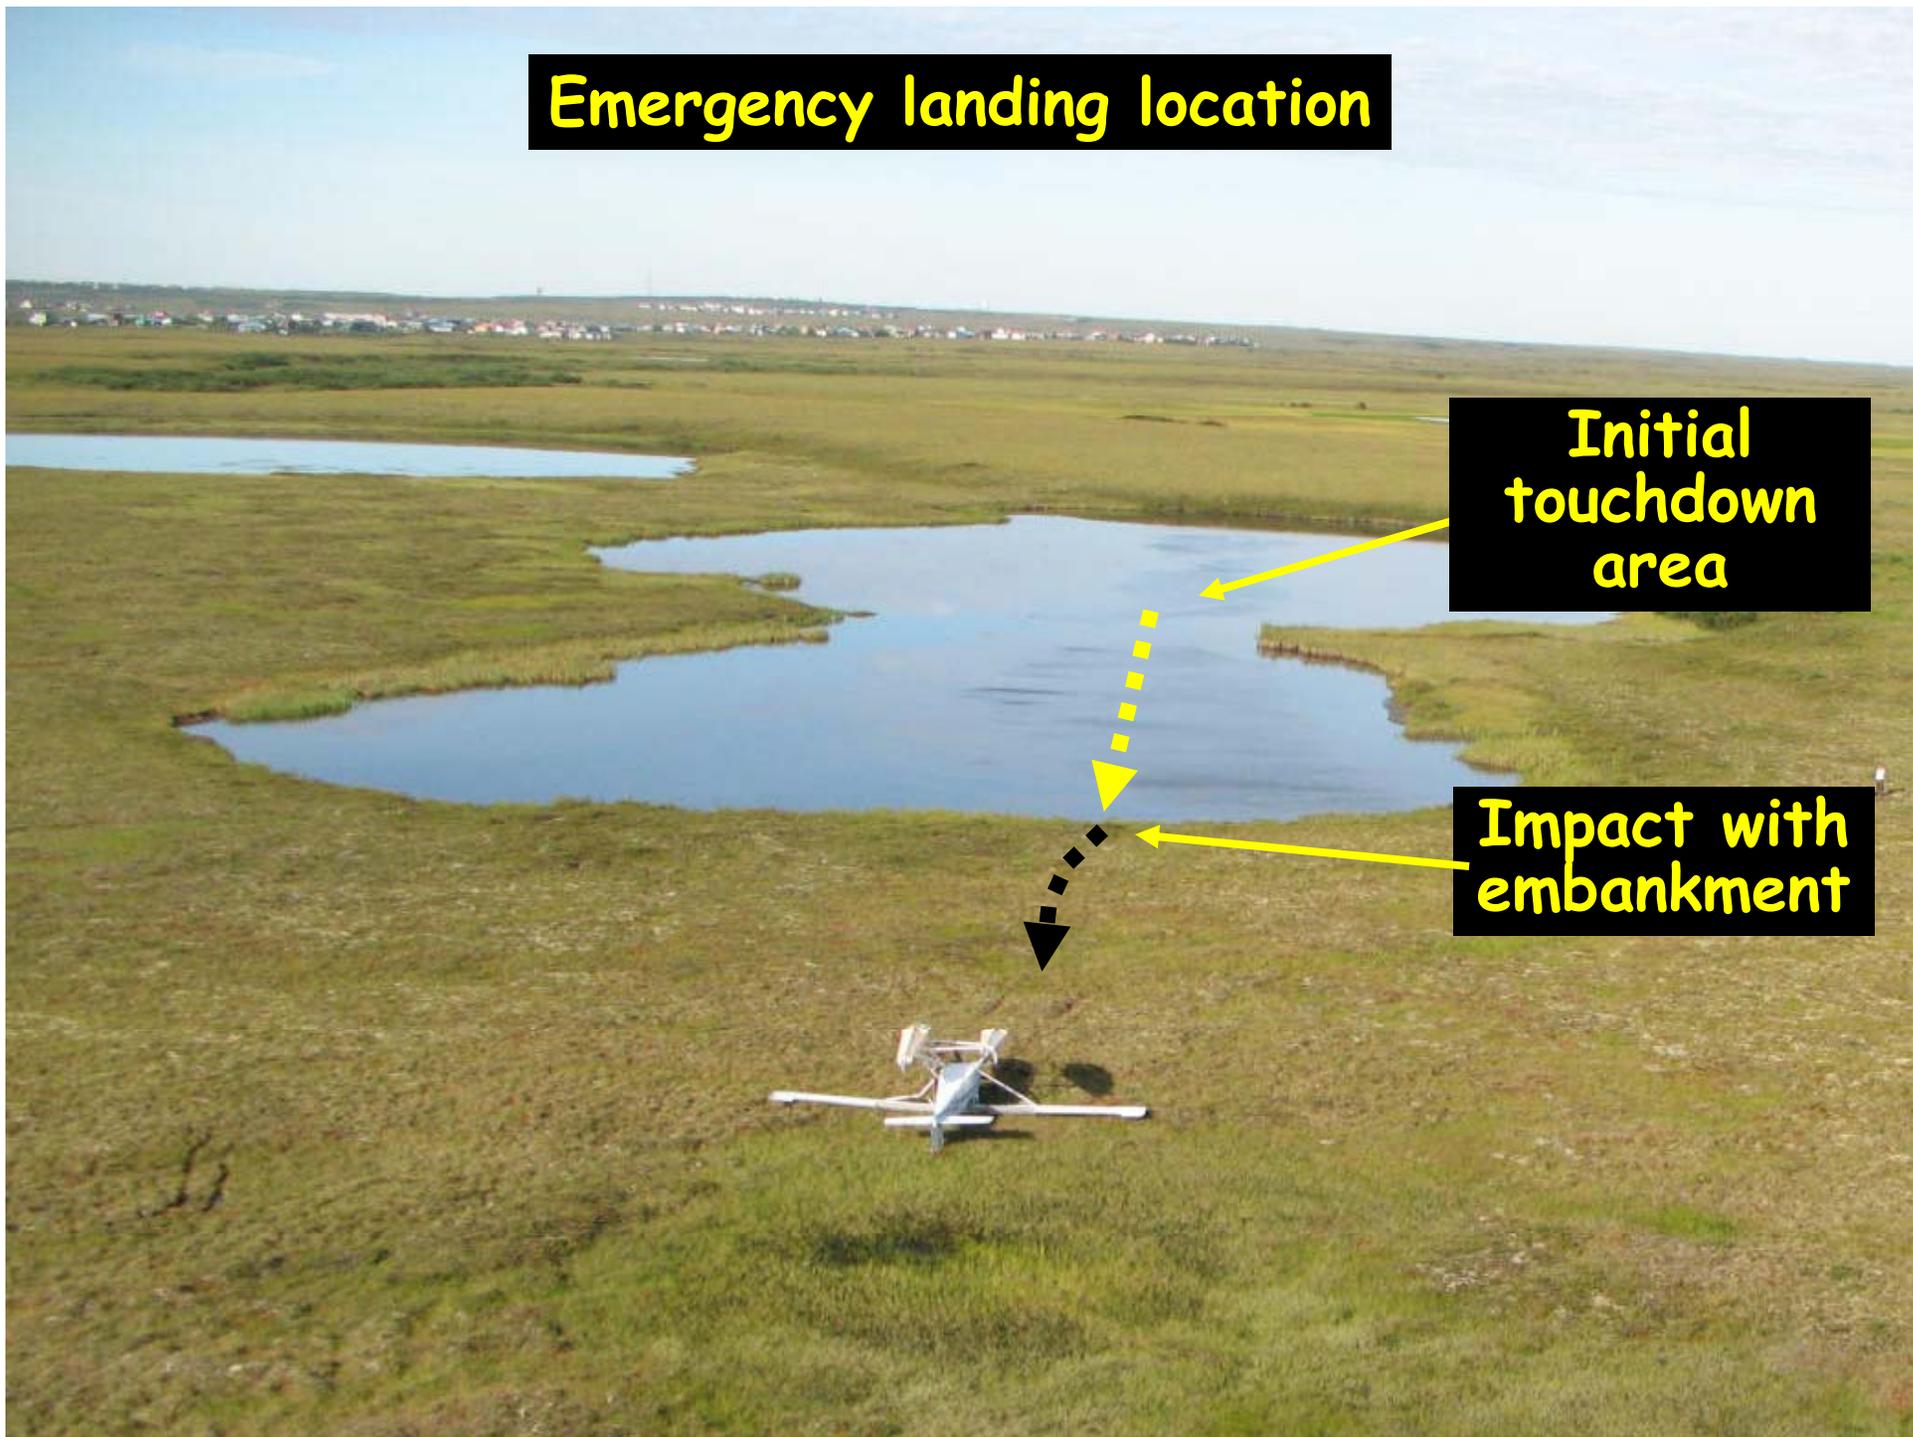
# Emergency landing location

Initial  
touchdown  
area

Impact with  
embankment

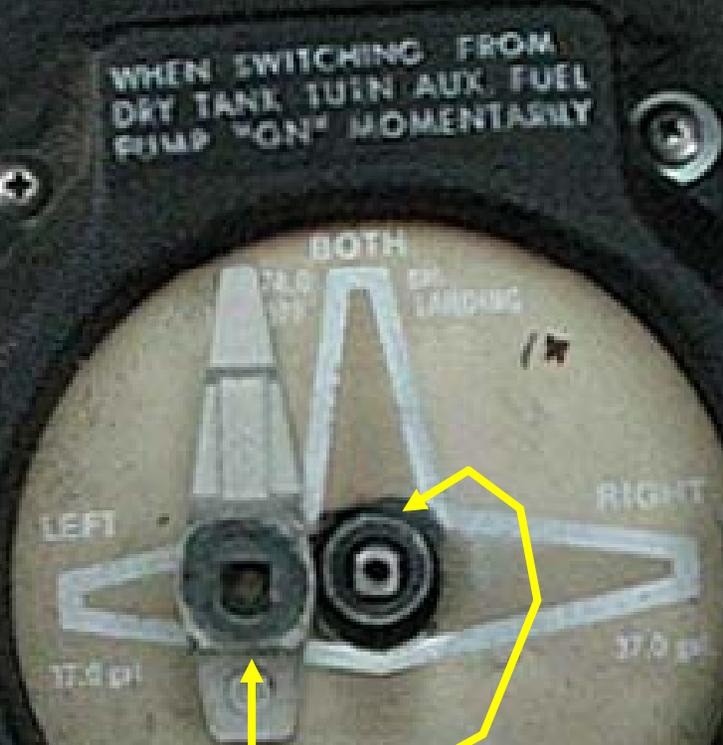
**The National Transportation Safety Board determines the probable cause(s) of this accident as follows: The improper [reversed] installation of the fuel selector handle by maintenance personnel.**

**Fuel Selector Valve  
(as installed)**

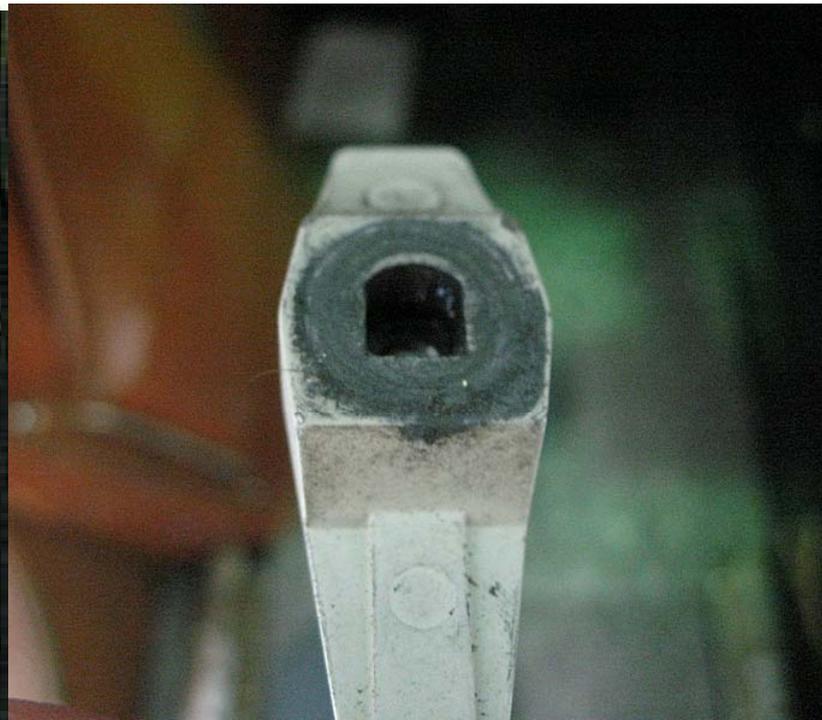
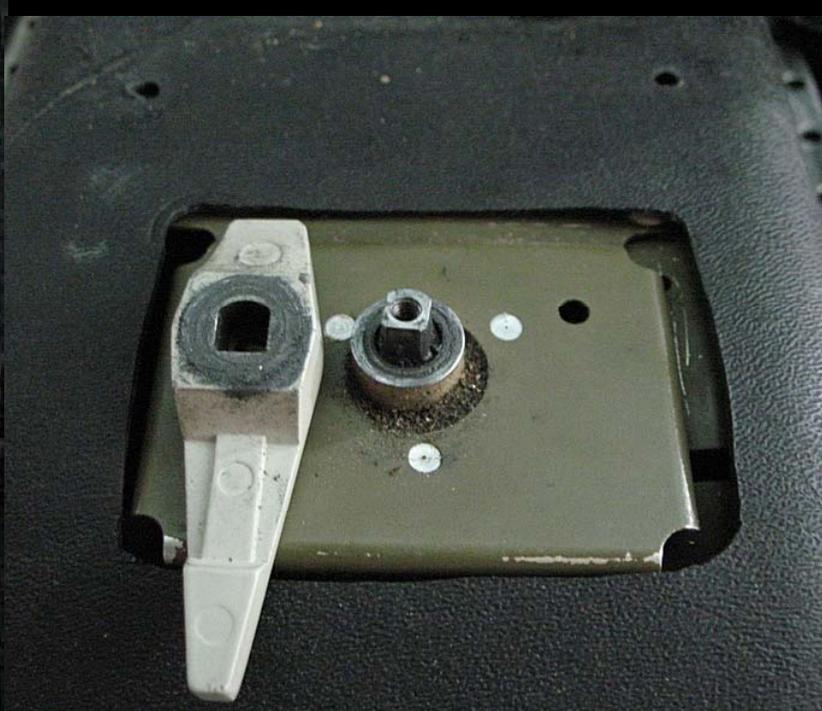
**Note three straight  
and one curved side**

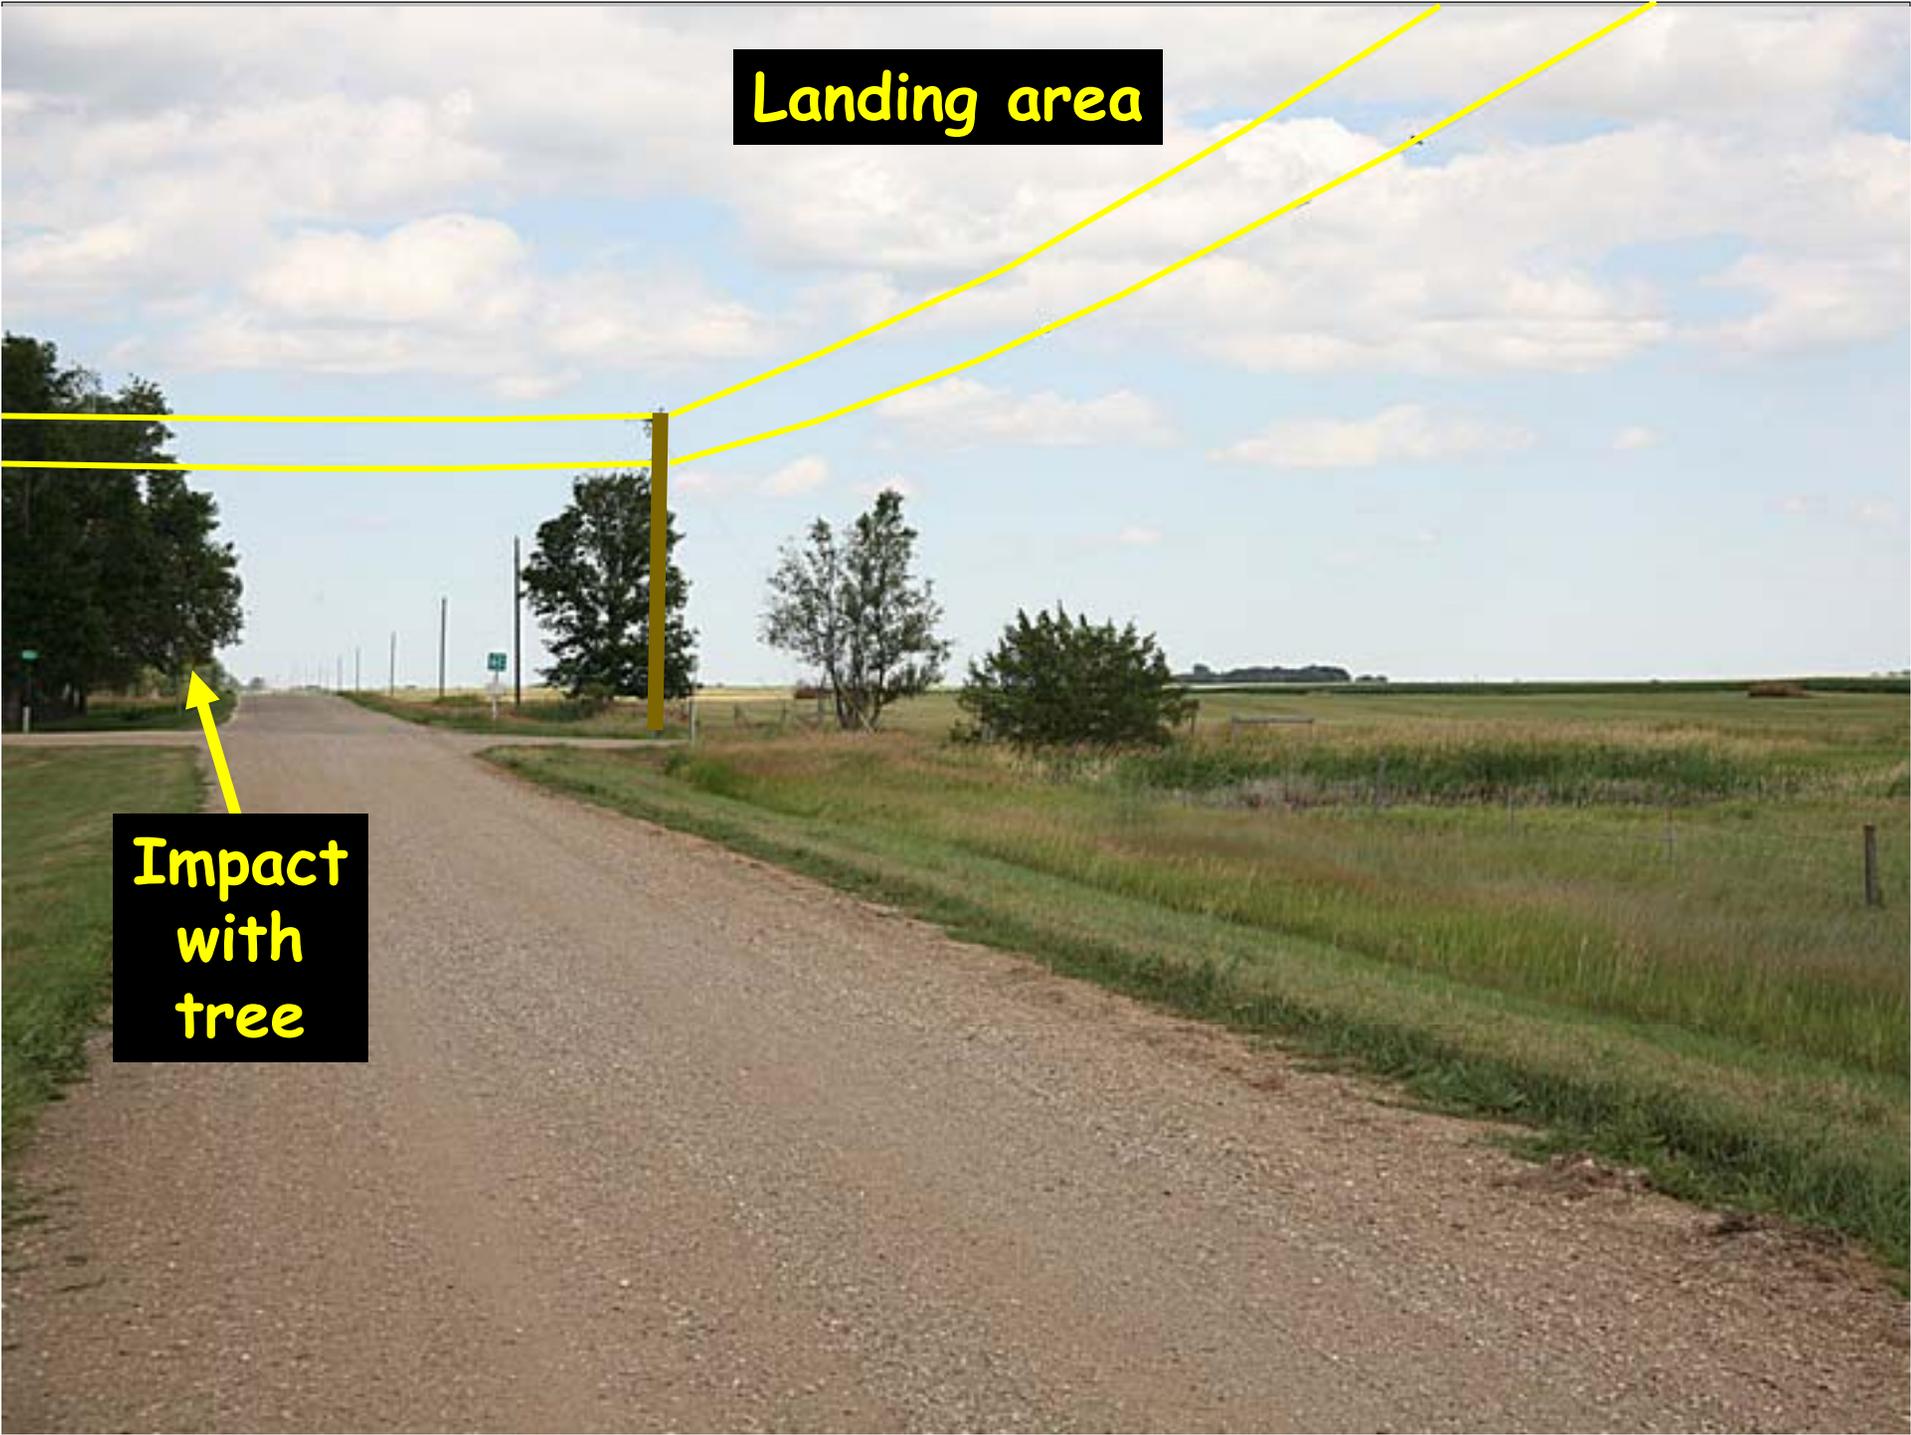
**Landing area**

**Impact with tree**
