# DOI FY 07 Aviation Mishaps

# DOI FY 07/08 Aviation Mishaps

This information is provided  
for accident prevention purposes only

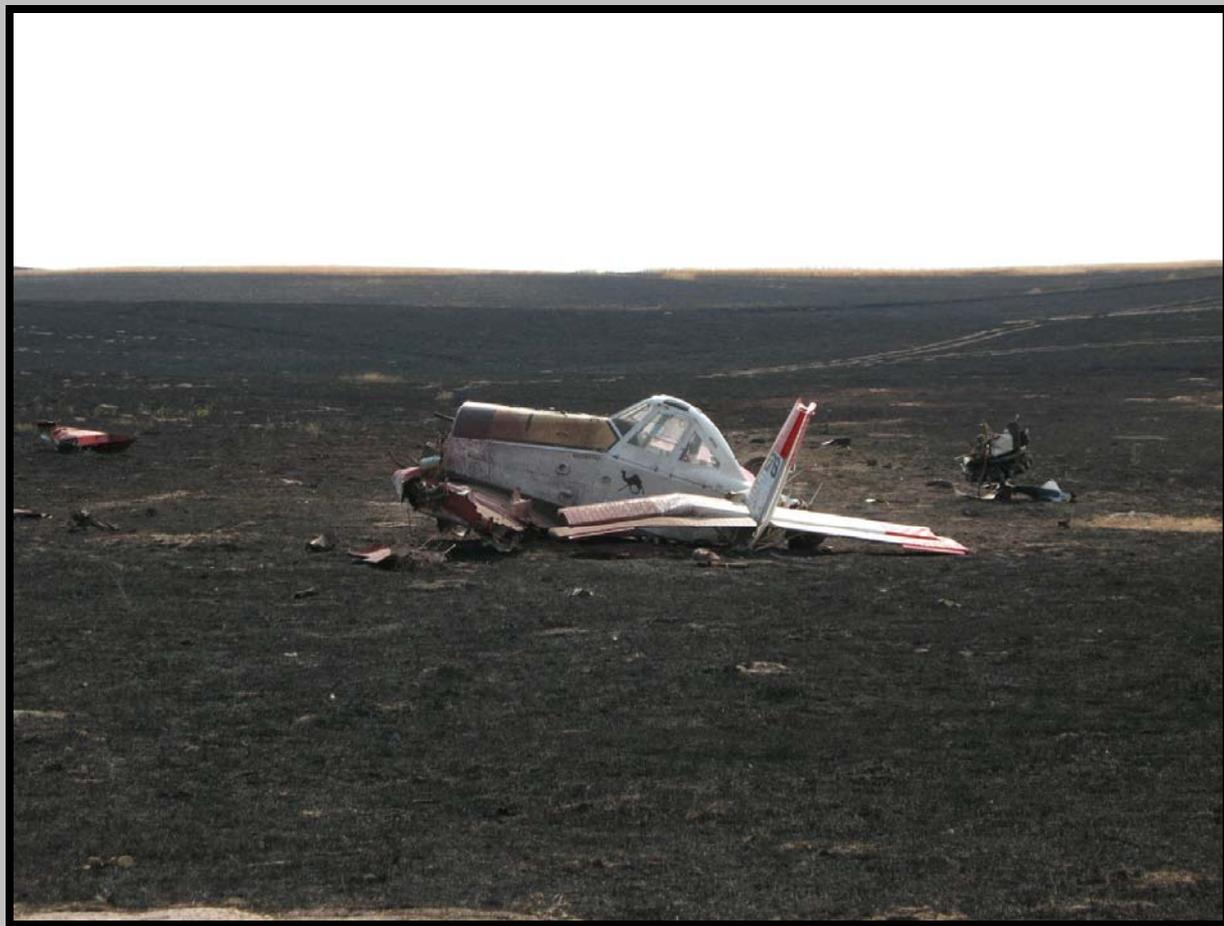
*Kyle, SD*  
*July 7, 2007*

The agricultural application airplane sustained substantial damage when it impacted terrain while maneuvering for a public use aerial application of fire retardant. The pilot stated that he was approaching a fire location from the northwest. He was crossing a "burnt area from west to east across gently rolling terrain." When he crossed a ridgeline, he encountered a downdraft and the airplane "wanted to settle." The pilot "pushed [the] nose over and released [the] load." The pilot stated that the airplane would not recover before impacting terrain. The pilot reported no mechanical malfunctions with the airplane in reference to the flight. Gusty winds were present in the area at the time of the accident.

**The National Transportation Safety Board determines the probable cause(s) of this accident as follows:** The pilot's failure to maintain clearance from terrain during an aerial application maneuver. Contributing to the accident were wind gusts, low altitude, and the reported downdraft.

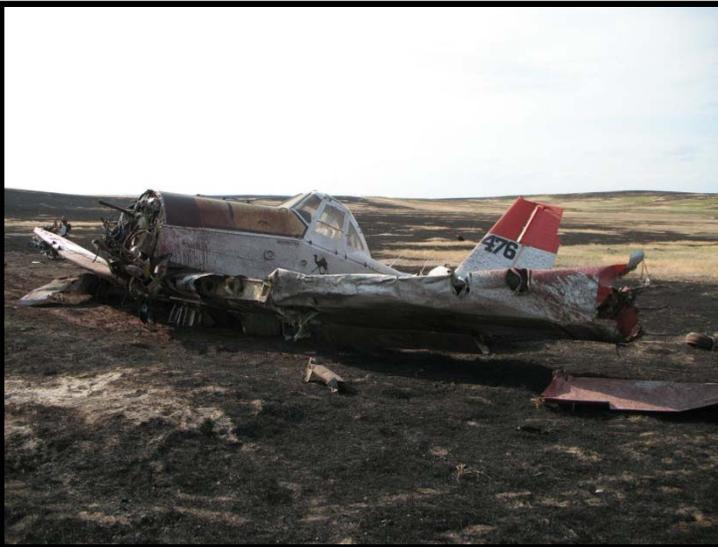
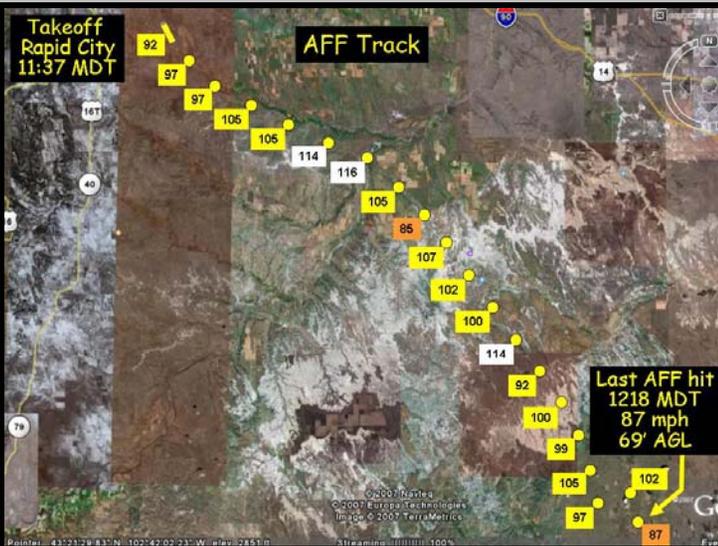
## Kyle, SD, July 7, 2007

- Basic airmanship (track, airspeed, and altitude)
- Compliance with Flight Manual Limitations (airspeed and bank angle)
- Compliance with contract (drop height, enroute altitude)
- Communications
- Risks associated with flying over "the black"

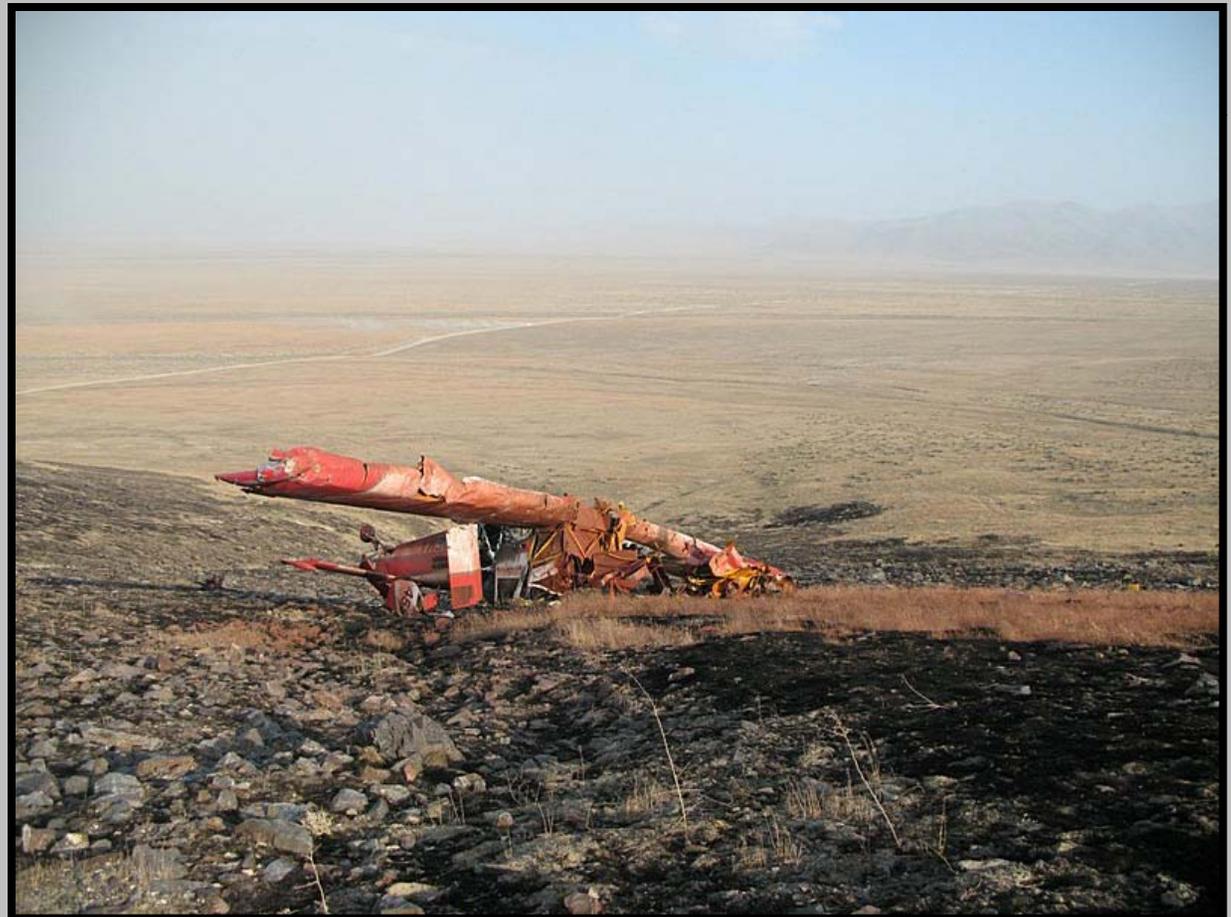
# Winnemucca, NV

The airplane, along with two others, was engaged in dropping fire retardant on a wildfire. The pilot planned on dropping his load into a retardant gap area that was created by the retardant drops of the other two air tanker aircraft. The pilot reported that he "was anxious to get [to the fire] because that fire was definitely on its way through the gap." During the first run of his drop, the pilot flew in a southerly direction heading downhill. After the first drop, the pilot said he "pulled off left and executed a 270-degree right turn to set up for another drop." The pilot began his second drop heading north uphill into rising terrain. After a few moments, the pilot realized the airplane would not out climb the terrain. He attempted a right turn to remain clear of the terrain; however, the airplane impacted about 10 feet below the crest of a hill in a level attitude. The pilot said that there were no mechanical problems with the airplane, and he had been caught by a downdraft during the drop.

**The National Transportation Safety Board determines the probable cause(s) of this accident as follows:** The pilot's failure to maintain clearance with terrain while maneuvering.

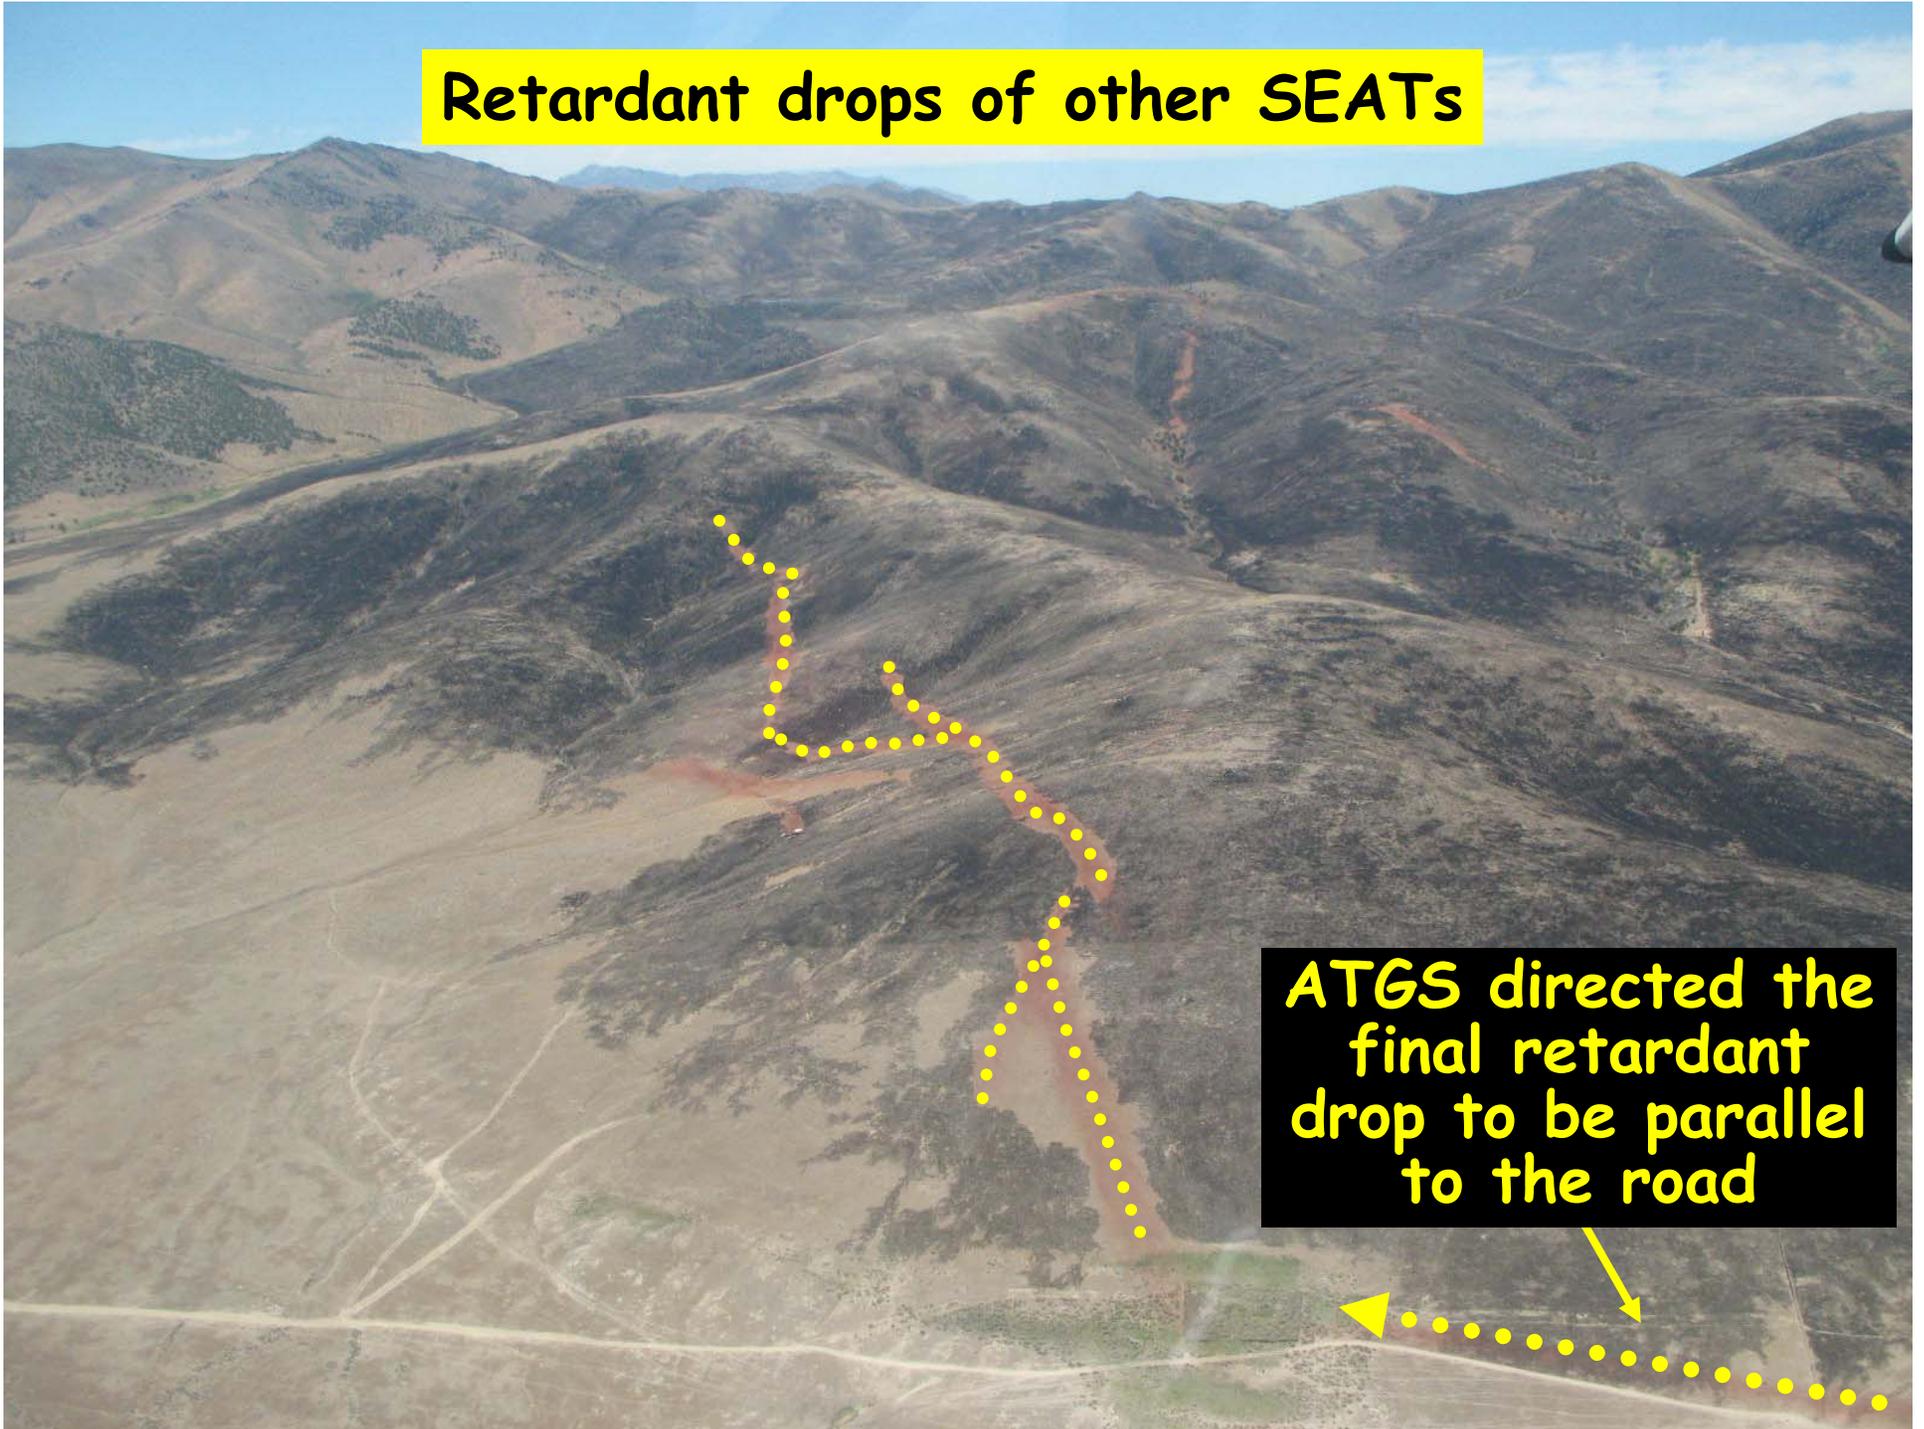
## Retardant drops of other SEATs

ATGS directed the final retardant drop to be parallel to the road

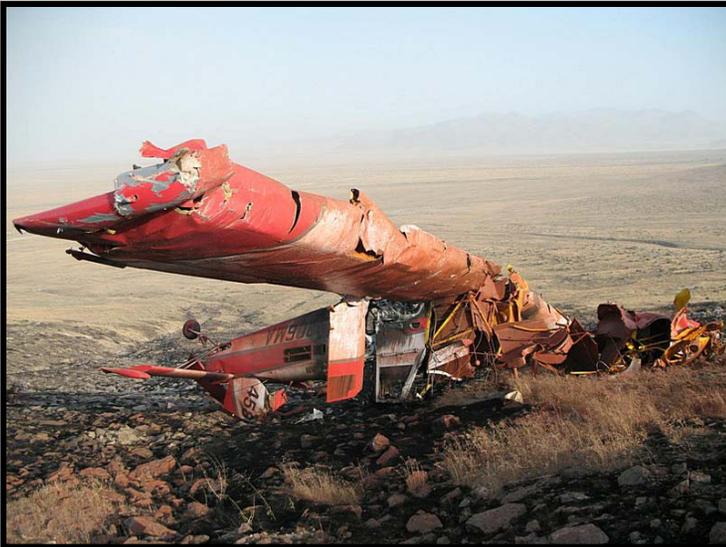
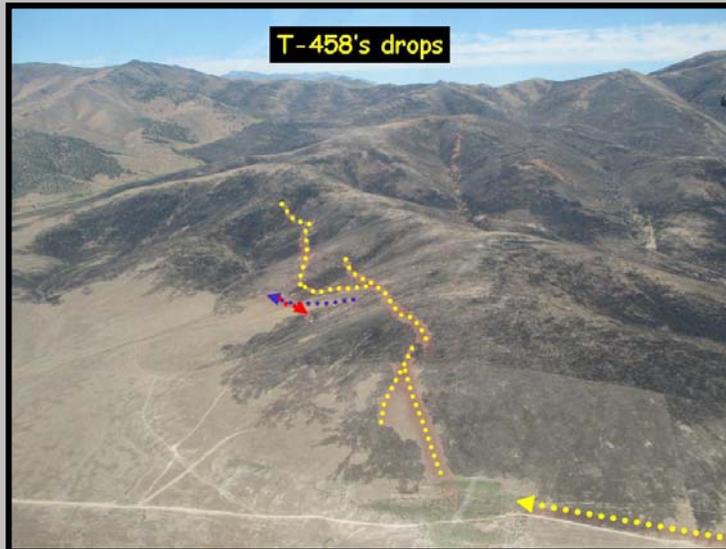
## Winnemucca, NV, July 17, 2007

- Basic airmanship (airspeed and altitude)
- Decision making (downdrafts and terrain)
- Compliance with contract (minimum drop height)
- Coordination with ATGS and IC
- Risk decision to operate SEATs in mountains vs. open valley

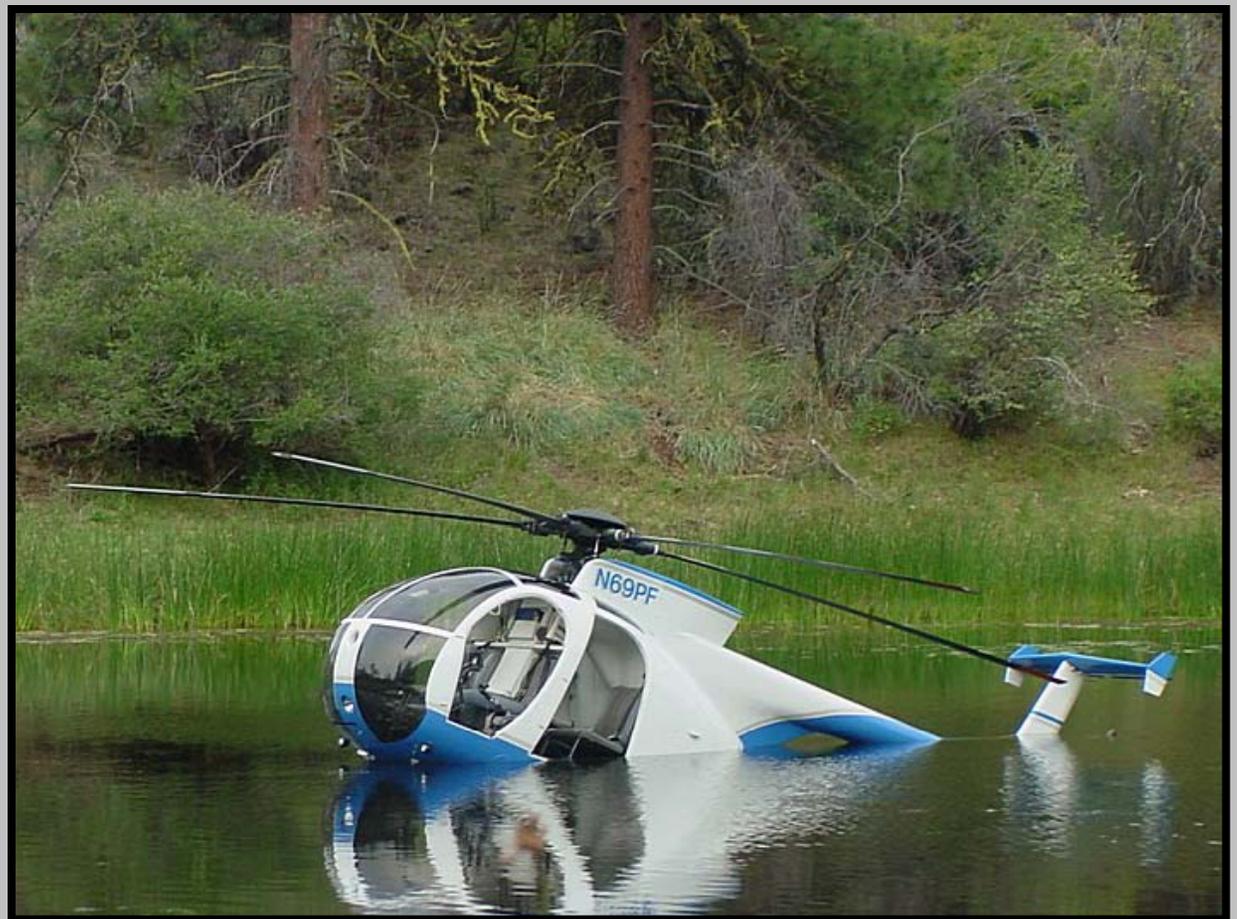
# Omak, WA

At the time of the accident, the pilot was descending into a hover over a pond that he was using for an aerial fire bucket refill site. As he began to level off in the hover, he heard a loud noise and felt an "accelerated vibration." Almost immediately thereafter, the helicopter began to spin to the right, so the pilot closed the throttle and made an autorotational landing in about three to four feet of water. A post-accident inspection of the helicopter revealed that the tail rotor driveshaft had failed in torsional overload, and that one of the tail rotor blades had experienced delaminating as a result of contact with the water over which the helicopter was hovering.

**The National Transportation Safety Board determines the probable cause(s) of this accident as follows:** The pilot's failure to maintain clearance from the surface of a pond that he was using as a water bucket refill site, which resulted in a tail rotor strike

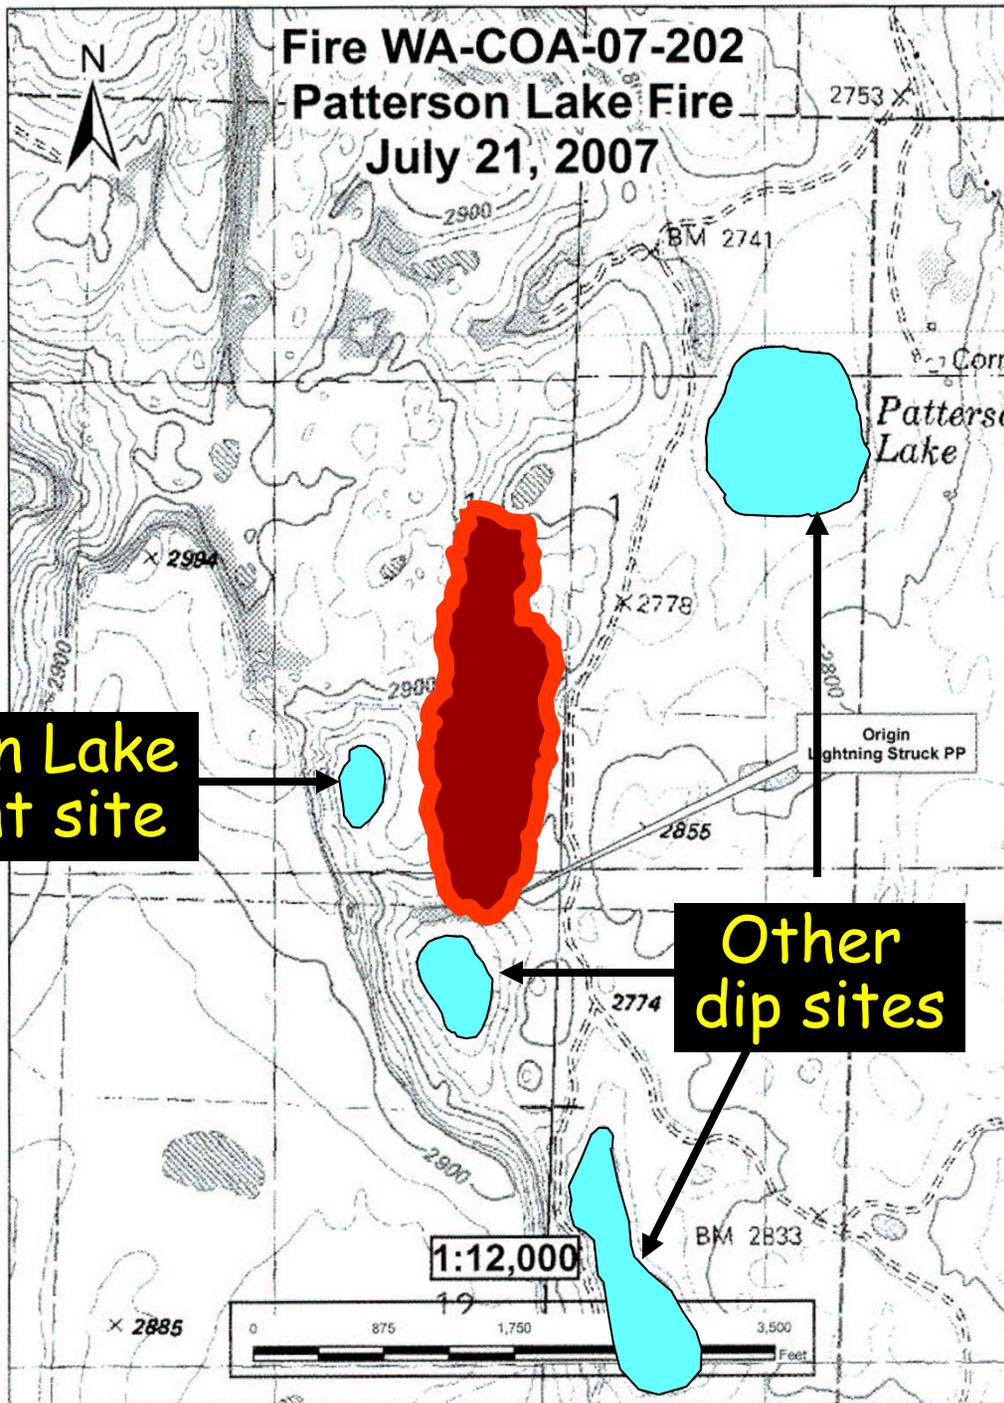
Cameron Lake  
accident site

Other  
dip sites

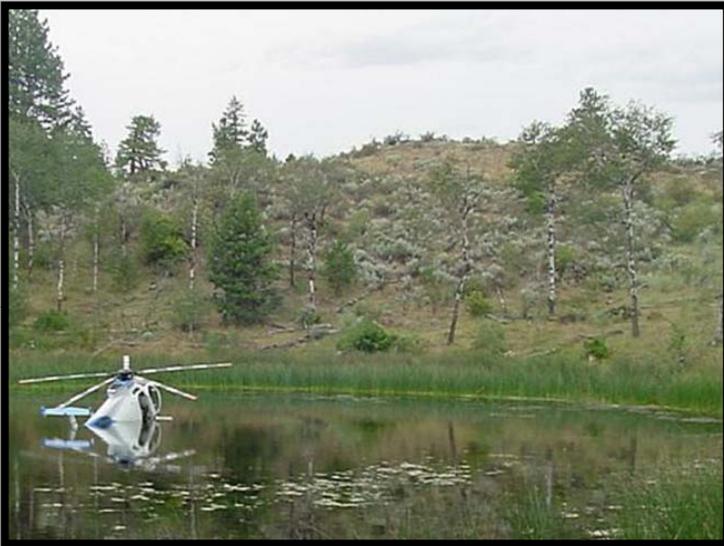
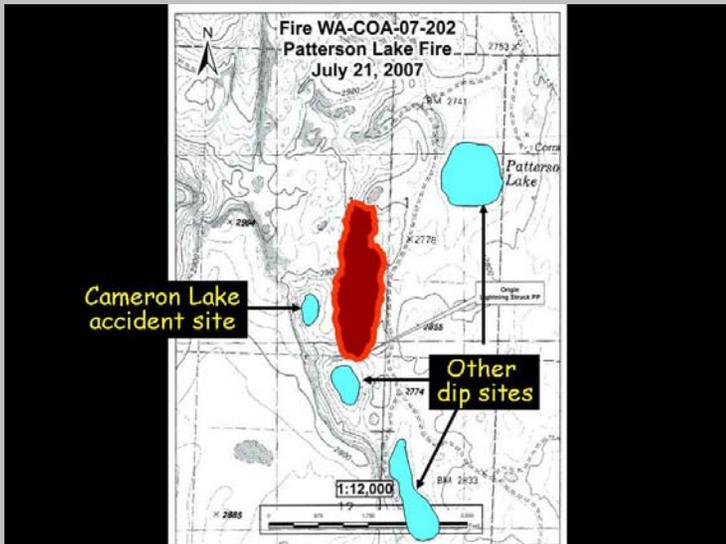
# AM Observations Omak, WA, July 21, 2007

- Basic airmanship (rate of closure, flare, and rate of descent)
- Decision making (selection of dip site and approach technique)
- Unnecessary risk-taking
- Dip site supervision
- Previous observations of pilot performance

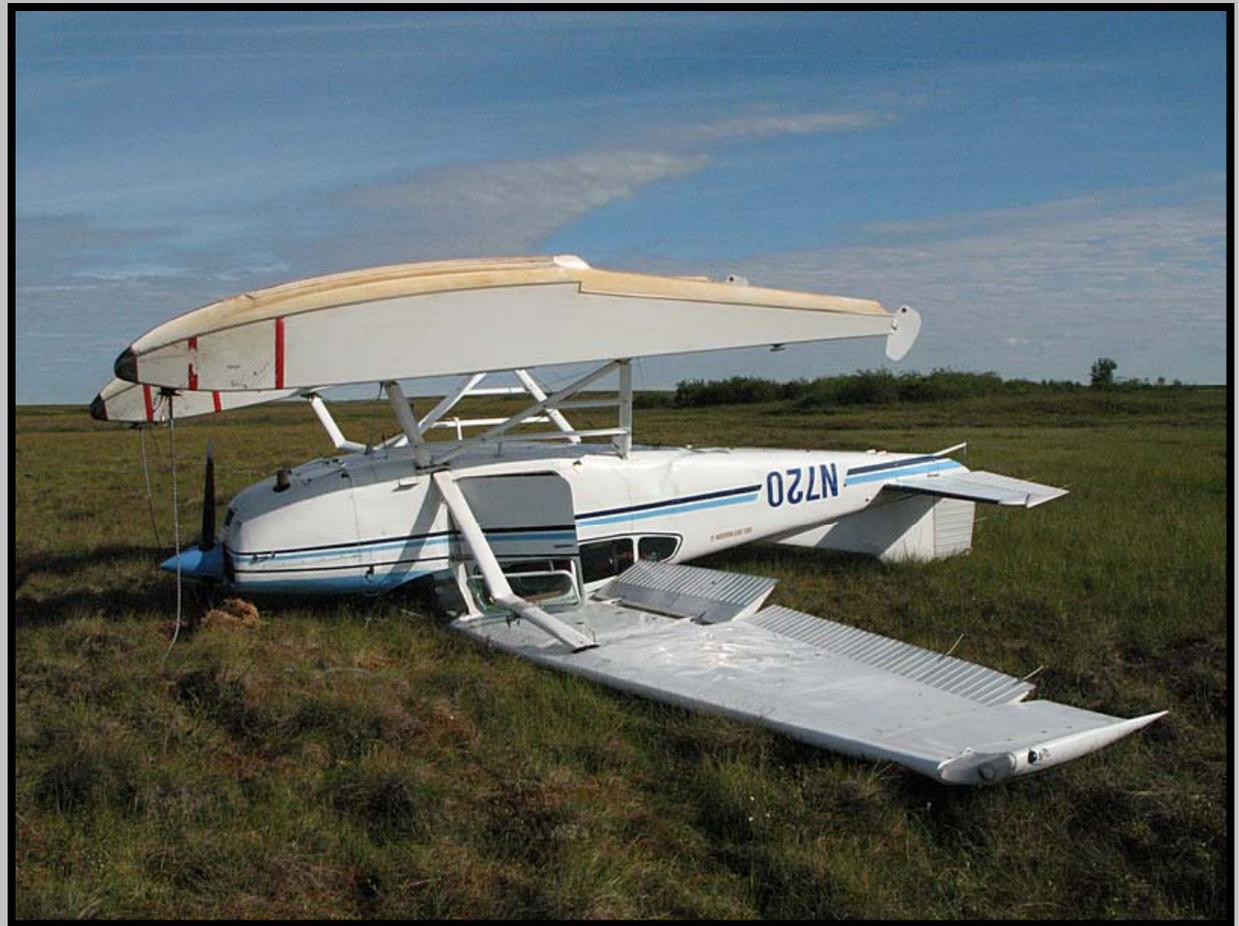
# Bethel, AK

**The commercial pilot was repositioning a float-equipped airplane to its mooring site after a 100-hour inspection. About 2 minutes after departure, the pilot reported a loss of engine power, and selected a small pond as a forced landing site. After touchdown on the pond, the airplane collided with the shoreline and nosed over. The airplane sustained substantial damage to the left wing, right wing lift strut, empennage, and fuselage. A postaccident inspection of the airplane revealed that the fuel selector handle had been inadvertently reinstalled incorrectly during the recent 100-hour inspection, and when the fuel tank selector handle was placed in the "Both" position, it actually turned the fuel supply off. Investigation revealed slight wear to the keyed cog of the fuel selector valve handle (female receptacle), as well as slight wear to the fuel selector valve connection point (male receptacle). The combined wear patterns of both the fuel selector valve handle and the fuel selector valve connection point allowed the installation of the fuel selector handle 180 degrees from its correct position. When a new fuel selector valve handle was fitted onto the valve connection point, it could only be installed in the correct position, and not 180 degrees from the correct installation.**

**The National Transportation Safety Board determines the probable cause(s) of this accident as follows: The improper [reversed] installation of the fuel selector handle by maintenance personnel.**

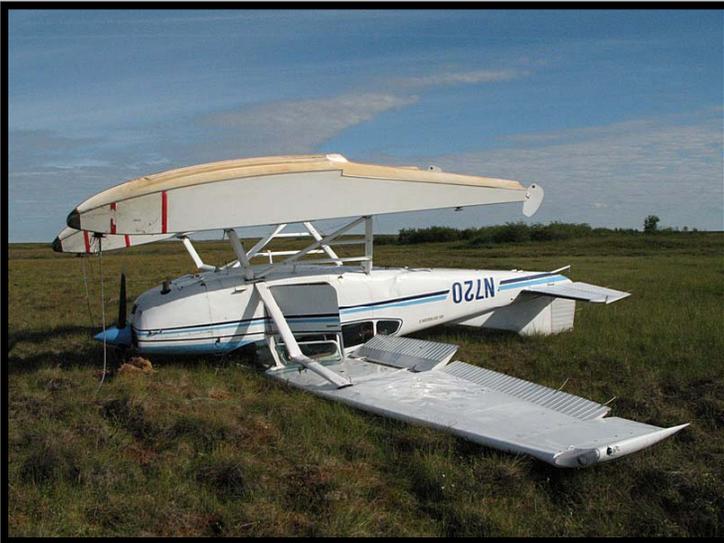
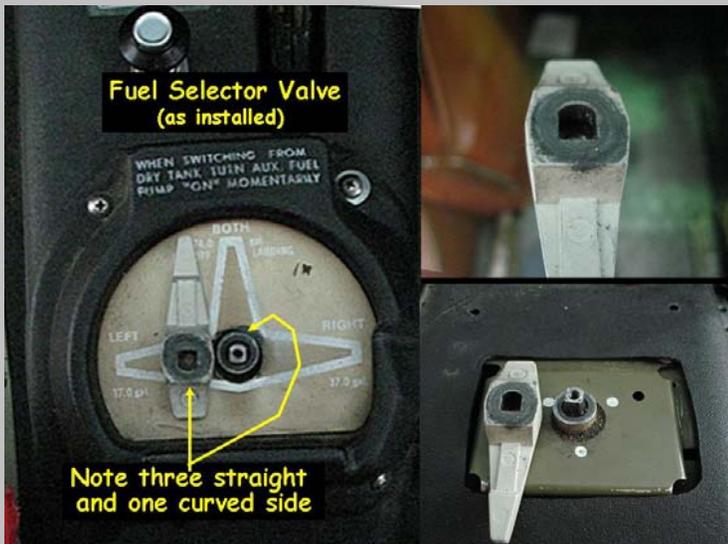
## Bethel, AK, August 8, 2007

- CRM for mechanics (teamwork, communications)
- Use of maintenance manuals and checklists
- Forced landing areas
- Altitude, altitude, altitude

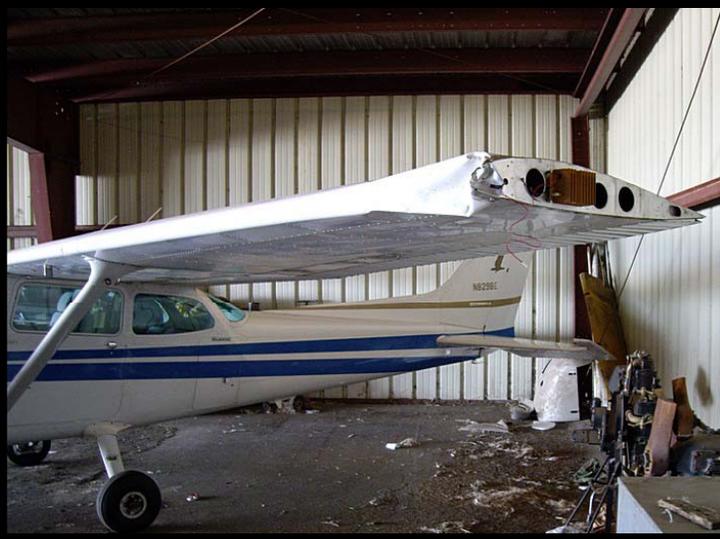
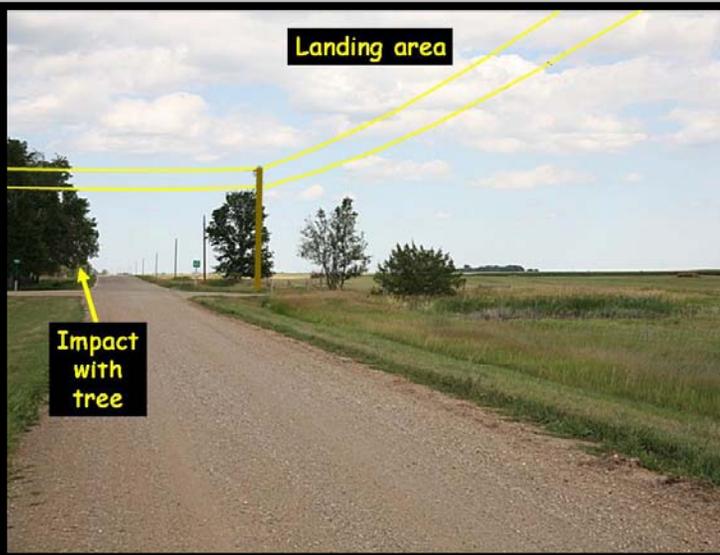
## Aberdeen, SD, July 11, 2007

- Pilot carding (vendor failure, Government employee failure)
- Pre-mission planning (pre-flight inspection, fuel quantity)
- Pilot decision making (CRM, fuel management, reaction to emergency, downwind landing, most conservative response rule)
- Dip the tanks and take more than the minimum (when the situation permits)
